Halfway, Silver, and Shantee Creeks Analysis

Prepared for
**U.S. Environmental Protection Agency
and Ohio Environmental Protection Agency**

Prepared by
**Tetra Tech, Inc.
1468 West 9th Street, Suite 620
Cleveland, Ohio 44113**

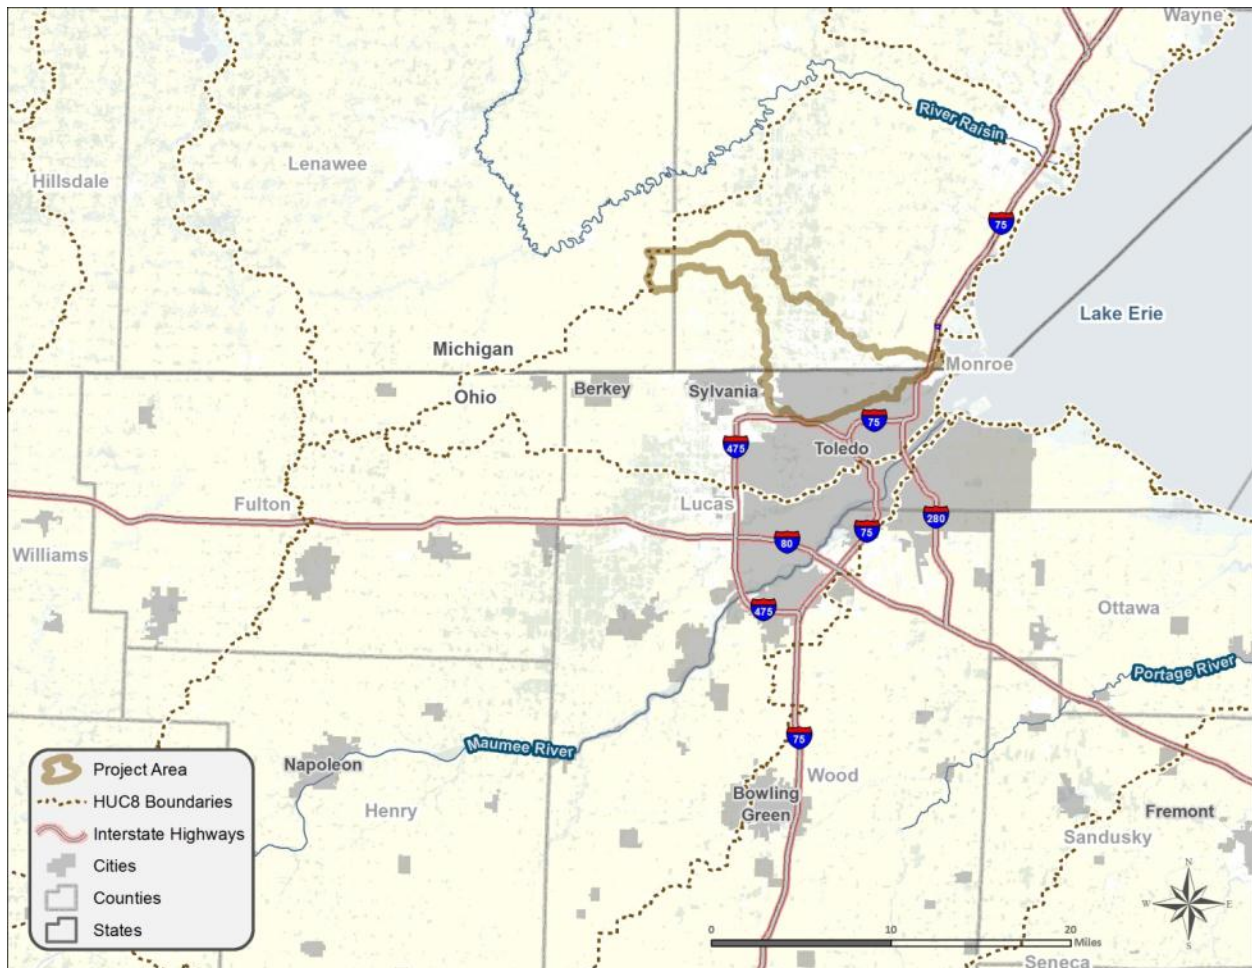
Halfway, Silver, and Shantee creeks are tributaries to North Maumee Bay in the greater Toledo area in the western basin of Lake Erie (Figure 2). Silver and Shantee creeks generally flow eastward through the city of Toledo and Sylvania and Washington townships of Lucas County in northwest Ohio. The Halfway Creek watershed is in Lenawee County and Bedford, Erie, and Whiteford townships in Monroe County in southeast Michigan; a portion of the watershed is also in the city of Toledo in Ohio. The HSSCA project area is composed of two 12-digit hydrologic units (HUs): *Shantee Creek* (hydrologic unit code [HUC] 04100001 03 01) and *Halfway Creek* (HUC 04100001 03 02). Due to re-routing of the streams, Shantee Creek now discharges to Silver Creek, which in turn, discharges to Halfway Creek; stream re-routing is further discussed in Section 2.2.

Figure 2. Northwest Ohio.

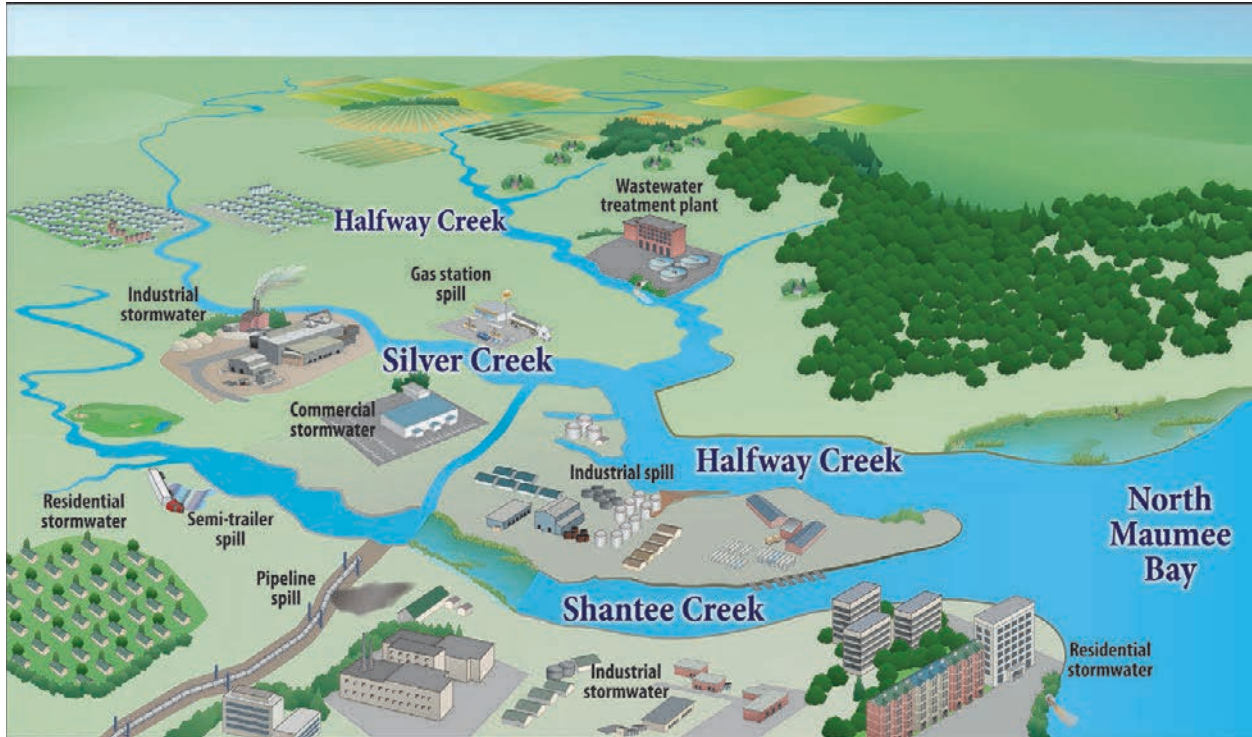
Figure 13 below conceptually summarizes the sources of POCs in the HSSCA project area. In Figure 13, the sources of POCs are represented as spills and releases (e.g., pipeline spill), urban stormwater (e.g., industrial stormwater), and non-stormwater point sources (e.g., wastewater treatment plant).

Note: Locations of sources on this figure do not correspond to actual locations of sources.

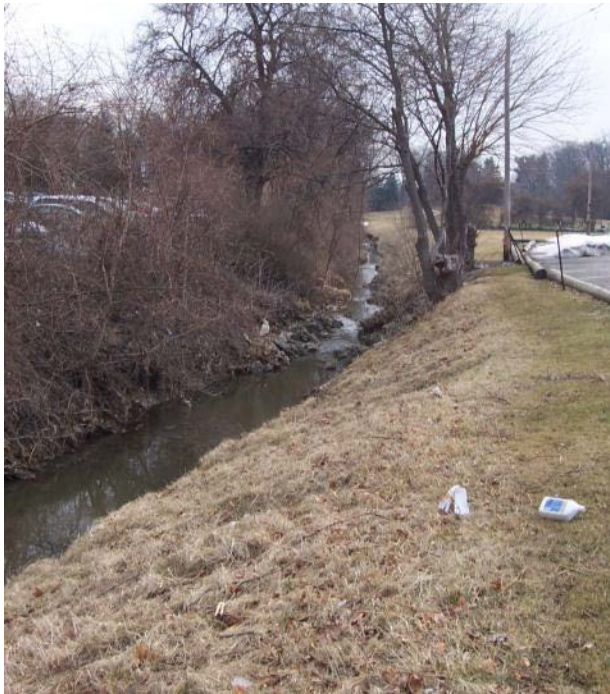
Along Tiff Ditch, there are isolated locations in commercial or mixed use areas that have potential for habitat restoration. Much of Tiff Ditch is channelized or routed underground through pipes. Typically, when Tiff Ditch is an open channel, there is not sufficient area along the banks in residential developments to restore a natural meander. However, Tiff Ditch east of Secor Road (Figure 17) is one segment where the banks are not held in place by riprap where there may be room to restore some meander and plant natural vegetation. Additionally, in Foxglove Meadow Park, which is surrounded by residential developments, there is sufficient room adjacent to Tiff Ditch to restore natural meander, plant native vegetation, and restore habitat (Figure 18).

Figure 17. Tiff Ditch at Secor Road (facing east, downstream).

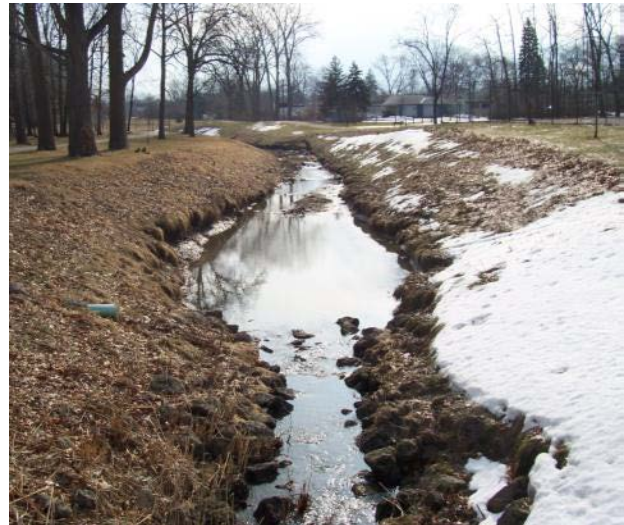
Figure 18. Tiff Ditch at Foxglove Meadow Park (facing east, downstream).

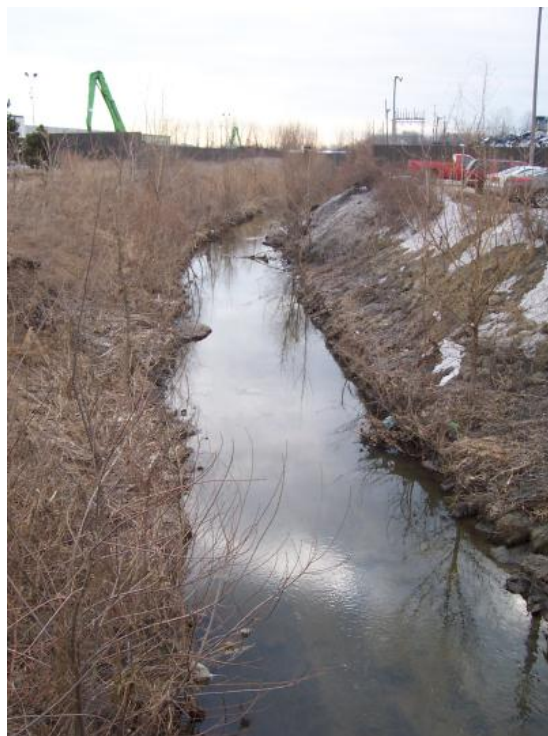
There is limited potential for habitat restoration along Shantee Creek in this critical area. Much of Shantee Creek in this critical area flows through commercial and industrial properties and is often adjacent to roads, buildings, or parking lots (Figure 22). However just east of Tractor Road, Shantee Creek flows through vacant lots (Figure 23), and this segment would have sufficient room for restoration activities.

Figure 22. Shantee Creek at Telegraph Road (facing east, downstream).

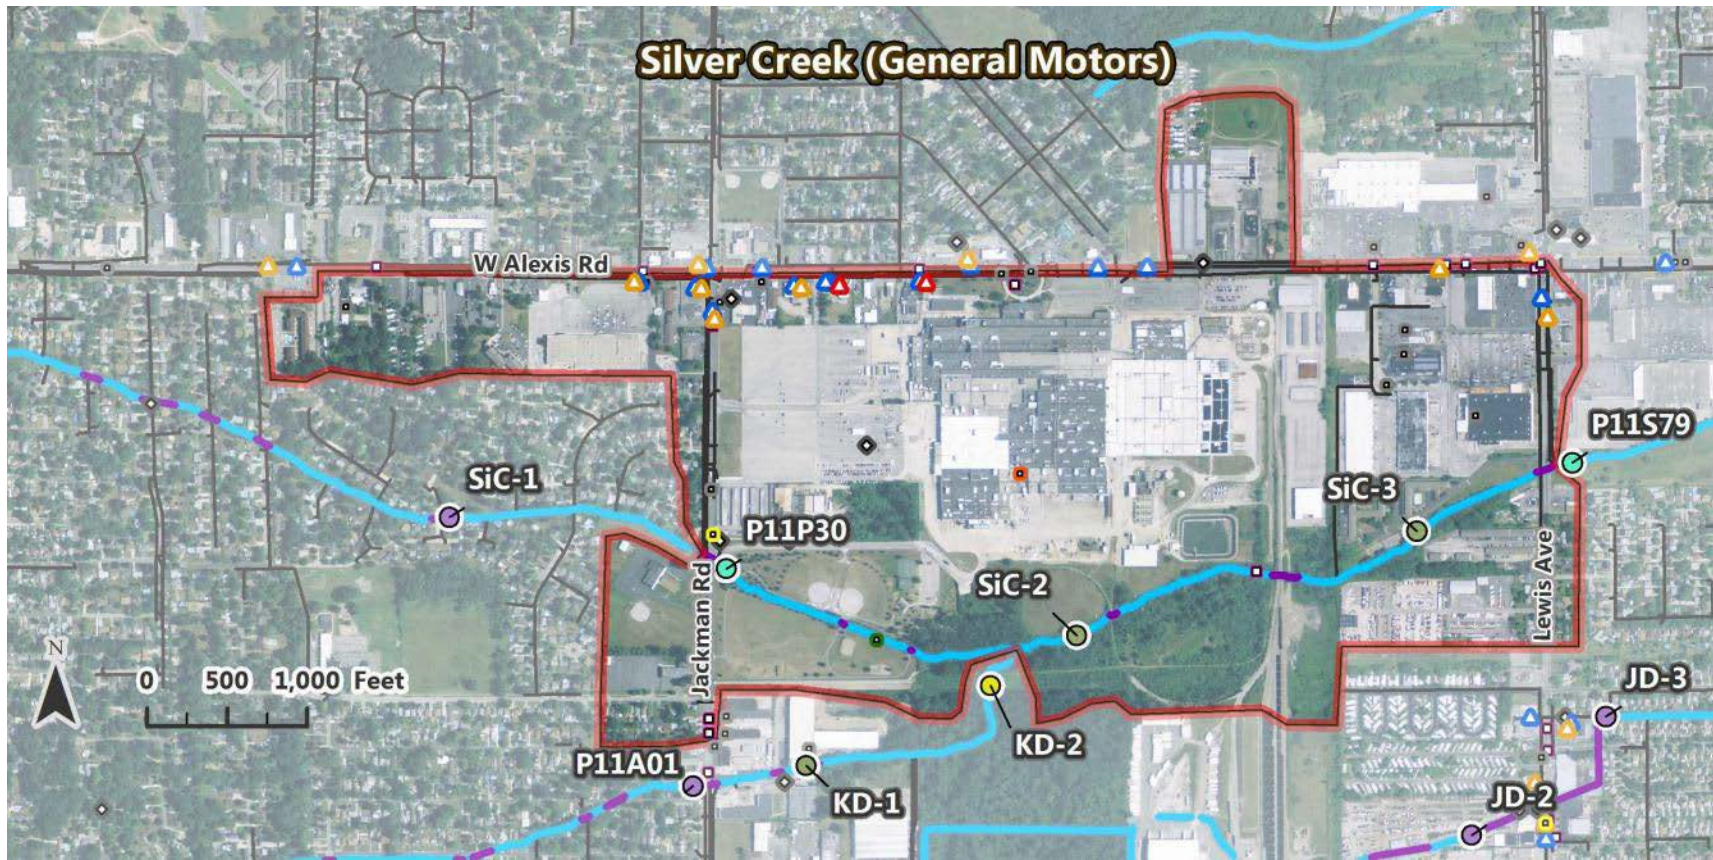
Note: Symbology for regulated facilities and spills is identical to the symbology in Figure 26 and is also shown on Figure E-1 in Appendix E.

Figure 27. Recommended sampling locations along Silver Creek upstream of and in the General Motors critical area.

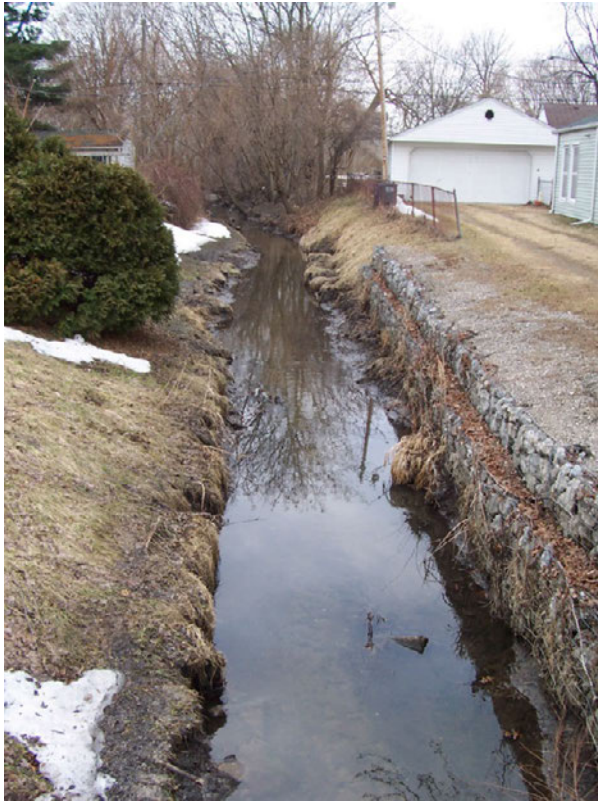
Figure 30. Ketcham Ditch at Adella Street (facing west, upstream).

There is limited potential for habitat restoration along much of Ketcham Ditch. The stream is channelized through much of the residential areas (Figure 30 and Figure 31), which tend not to have curbs and gutters. Due to the channelization, use of riprap for bank stabilization, and nearby structures, it's not feasible for channel or habitat restoration. However, there are isolated properties (e.g., a small vacant parcel) that could provide restoration opportunities along Ketcham Ditch. With the exception of the mouth of Ketcham Ditch, which is in a forested riparian corridor, resources should be devoted to other subwatersheds in the HSSCA project area with better restoration opportunities.

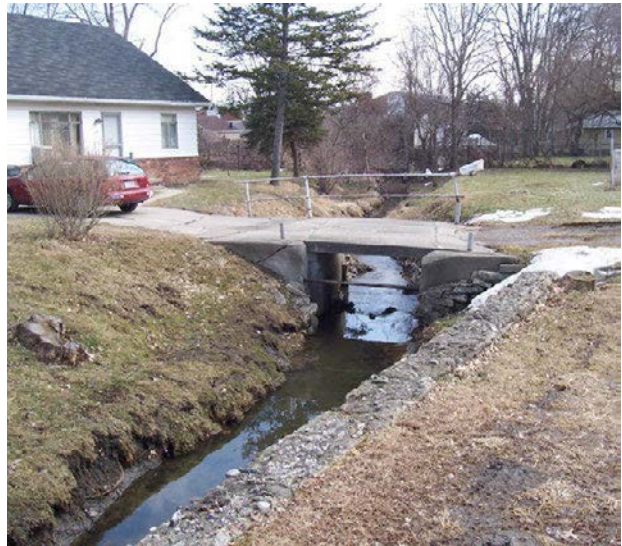
Figure 31. Ketcham Ditch at Ketner Avenue (facing northeast, downstream).

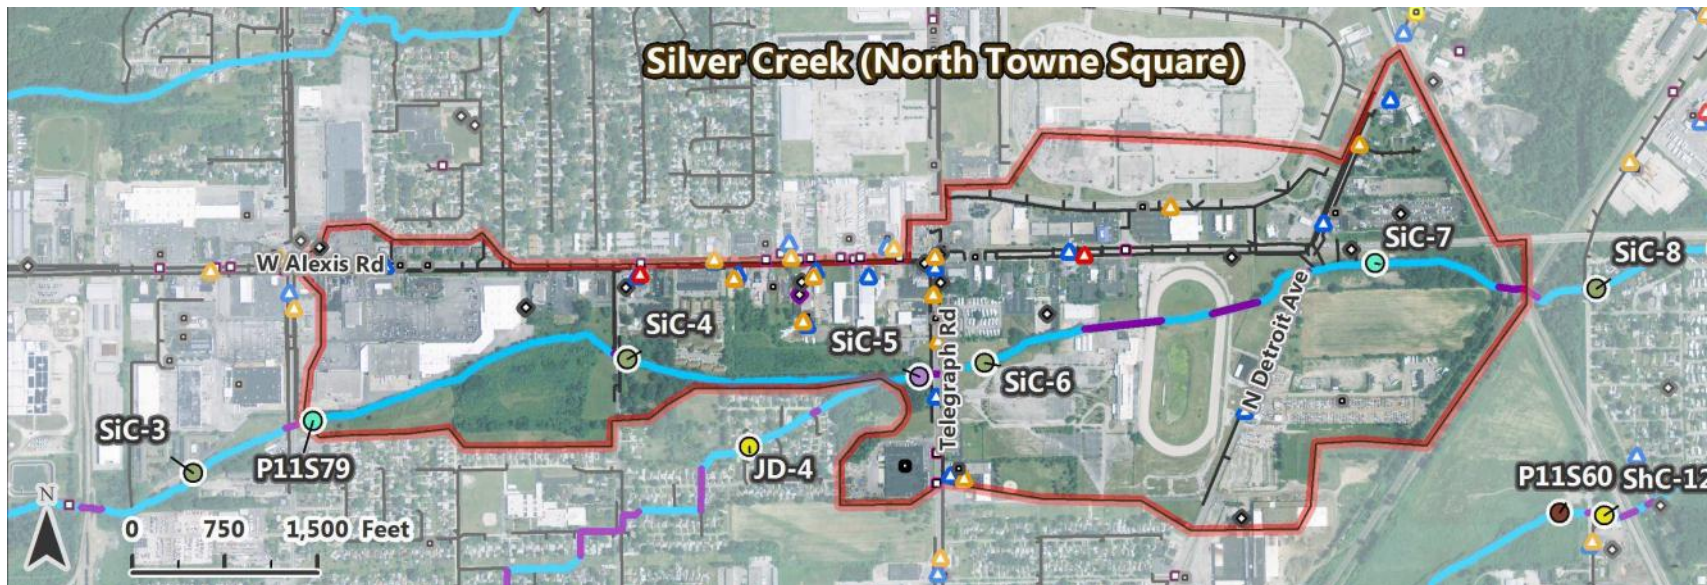
Note: Symbology for regulated facilities and spills is identical to the symbology in Figure 34 and is also shown on Figure E-1 in Appendix E.

Figure 35. Recommended sampling locations in and downstream of the North Towne Square critical area.

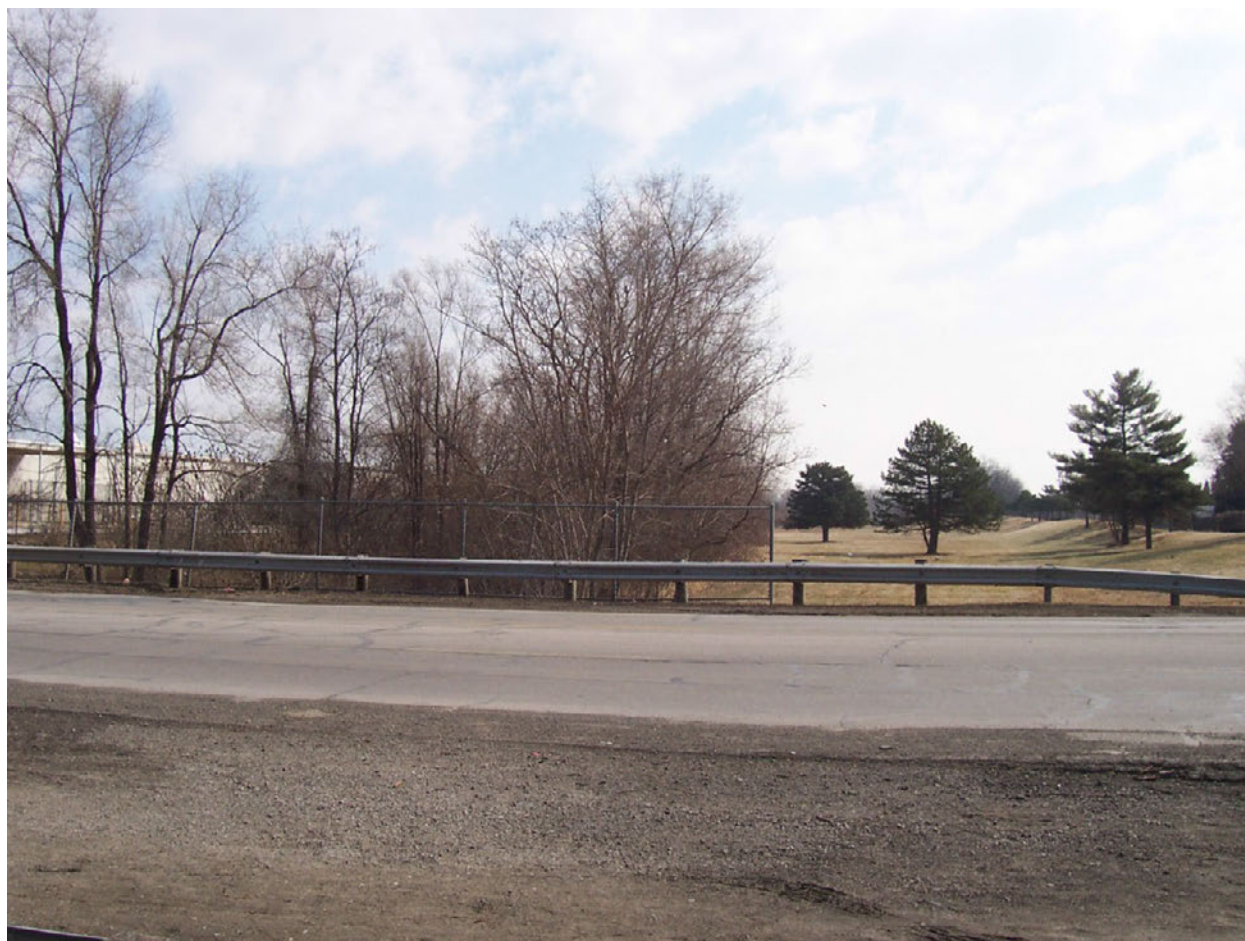
Long segments of Silver Creek in this critical area are open channels with forested riparian areas (Figure 36), which may be the remnants of the former Sunnybrook golf course. Unlike many other subwatersheds, where streams are frequently culverted and routed through underground pipes, this subwatershed has the potential for riparian habitat restoration. For example, sufficient land is available along Silver Creek east of Lewis Avenue for restoration activities and some segments already include trees within the riparian corridor (Figure 36). Restoration opportunities are likely limited between Telegraph Road and North Detroit Avenue as Silver Creek flows through commercial properties. The city of Toledo is working on Silver Creek from North Detroit Avenue to the railroad right-of-way (Figure 36) and anticipates installing a two-stage ditch in this area.

Figure 36. Lewis Avenue bridge over Silver Creek (facing east, downstream).

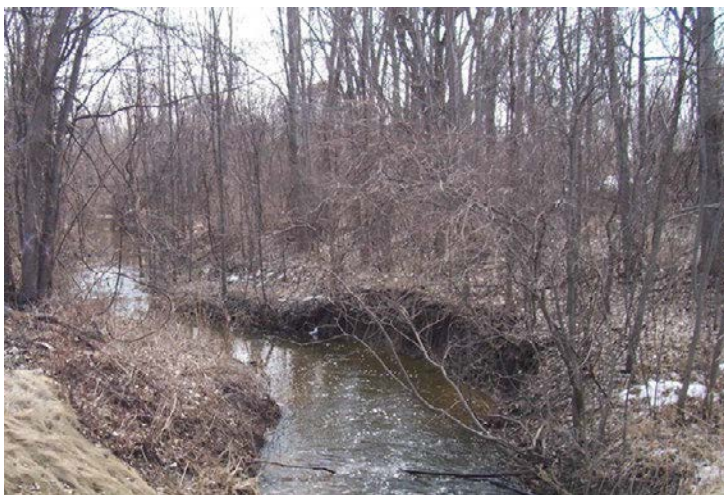
Figure 43. Halfway Creek at East State Line Road.

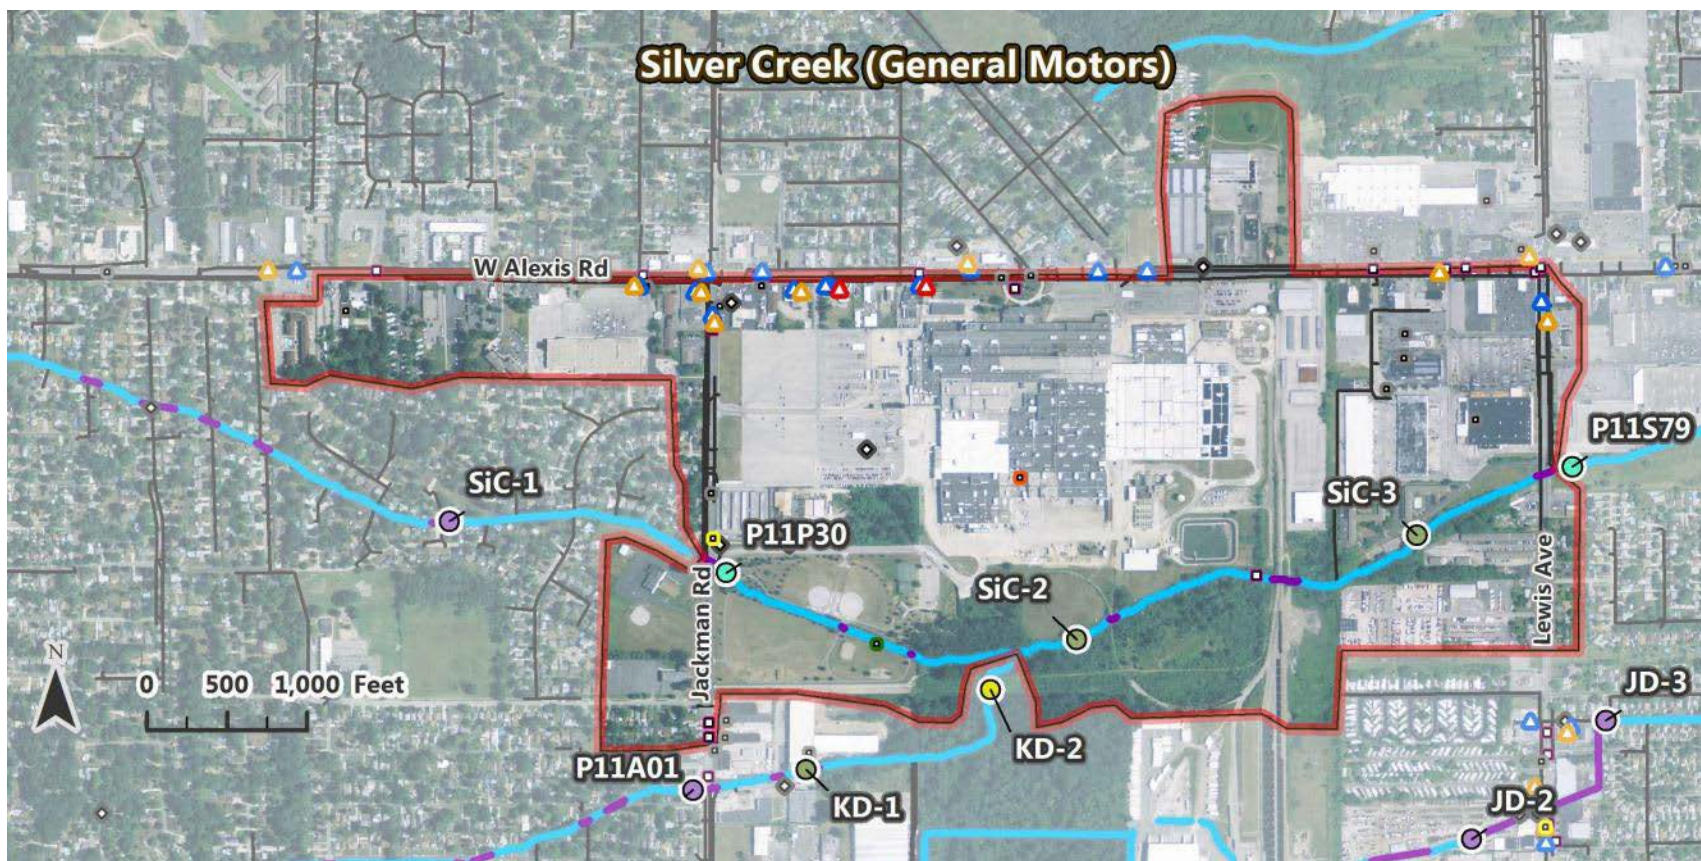
Figure E-6. Recommended sampling locations along Silver Creek upstream of and in the General Motors critical area.

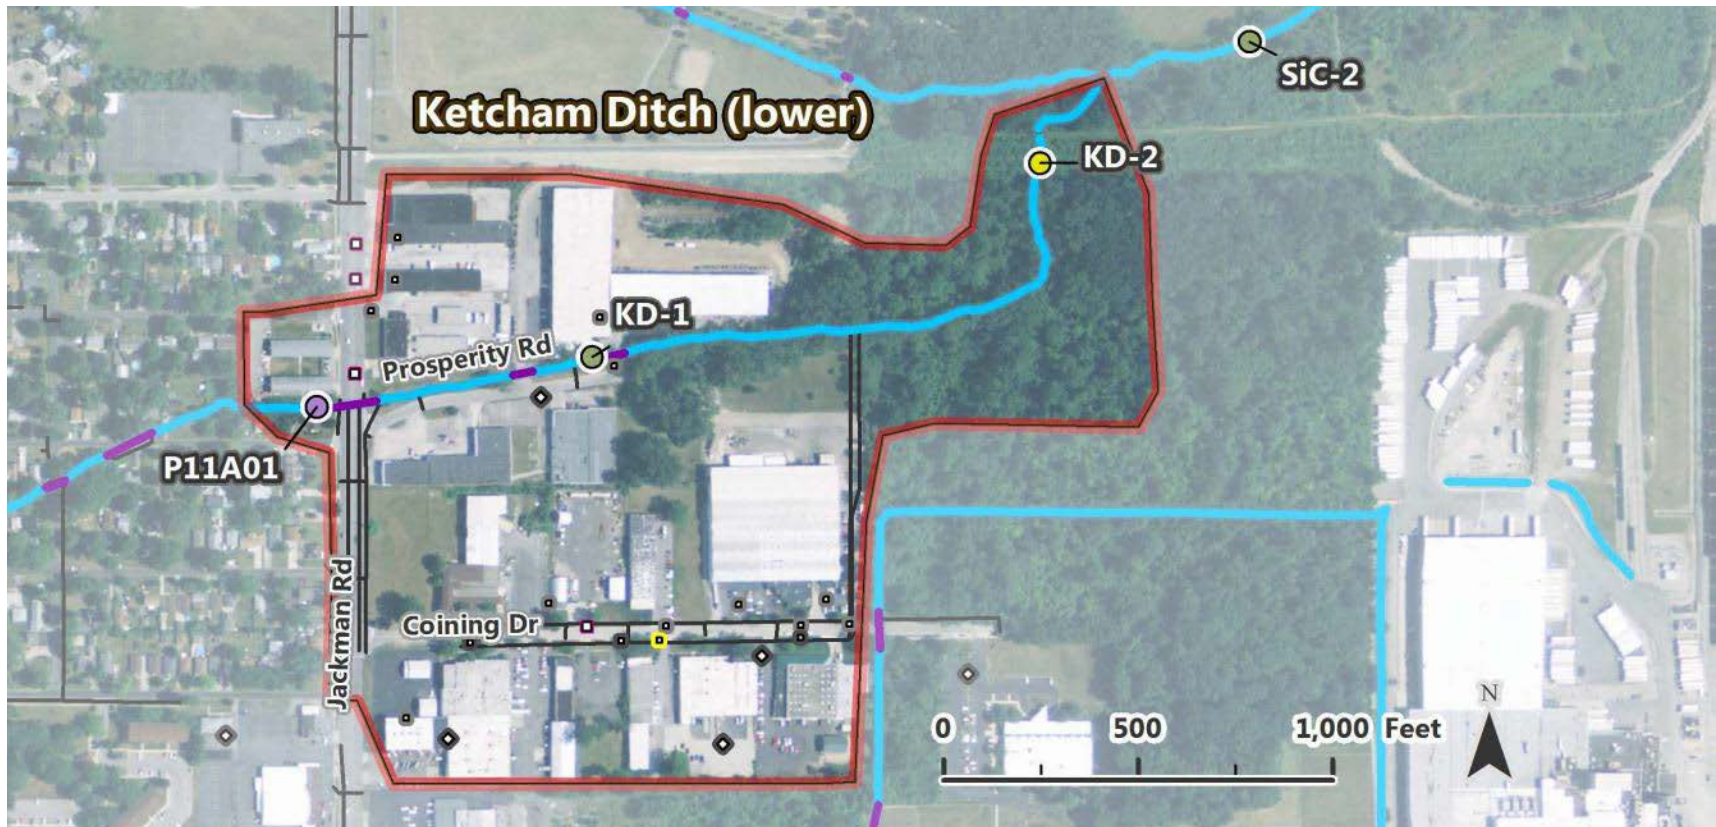
Figure E-7. Recommended sampling locations in the Ketcham Ditch (lower) critical area.
