# Secor Rd. Dam Removal & Stream Restoration

## Improving the Ottawa River

### Post-Project Fact Sheet

October 2012

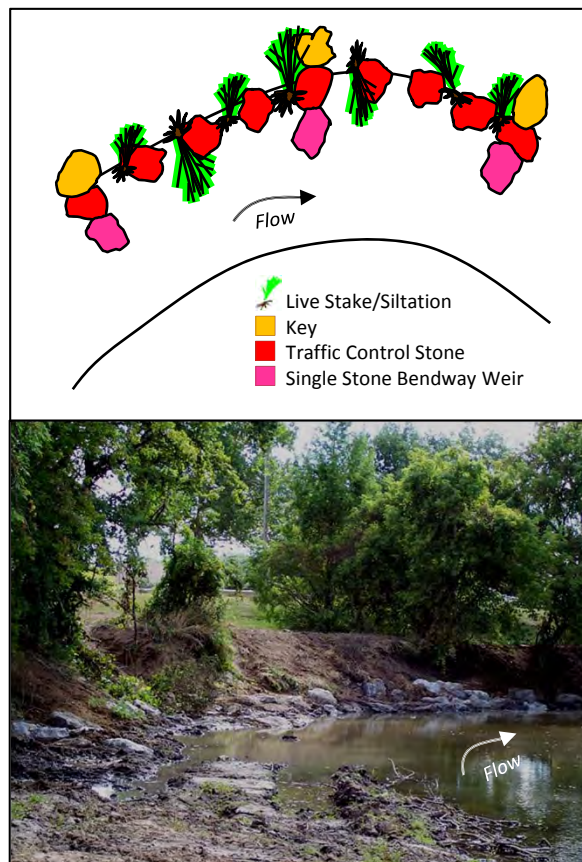
(top) The diagram illustrates the middle bend of this project.  
(bottom) The middle bend post-construction.

Single Stone Bendway Weirs were used to help redirect the flow of the river around the bend and down through the center of the created riffle. In general, a Bendway Weir redirects the water flowing over the weir back towards the center of the stream and away from the bank. A set of weirs are designed to

act as a system to capture, control, and redirect current and velocity through the bend and reduce erosion. The stone used for this project was approximately 2' x 3' x 5'. There were three sets of single stone Bendway Weirs installed on this site. Two of them were placed upstream of the riffle and one is downstream to help align the highest current to the center of the channel before going under the Secor Road bridge.

Traffic Control Stones (TCS) were used to help protect the outside bend and aid in establishing vegetation. A series of large stones (2-3 tons each) were placed at the base of the slope at approximately 8-10 feet apart. Each stone was embedded into the toe of the slope, so that the top of the stone would be just below the normal high water mark. As the water flows downstream the outer bank receives the majority of the energy. The TCS helps to deflect that energy and the associated vegetation absorbs energy and slows the velocity, thus reducing erosive forces.
