HOW STREAMS WORK & ENVRONMENTALLY SENSITIVE GRADE CONTROL

GRADE CONTROL

ENGINEERED ROCK RIFFLES,

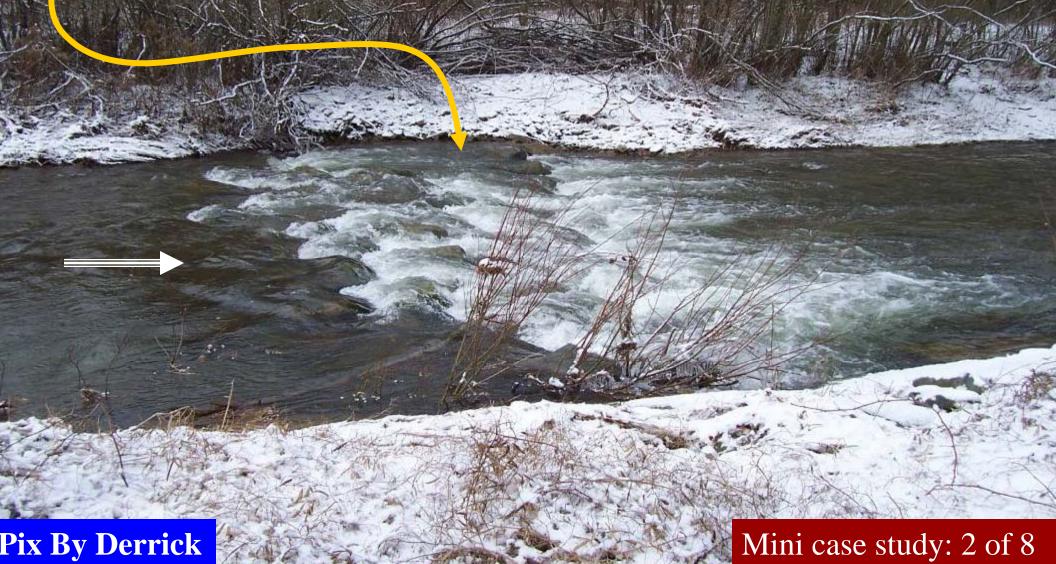
Chenunda Creek, Willing, NY. Post construction 1/9/2007. Looking across at a 2-ft tall steep-sloped Engineered Rocked Riffle {ERR} with integrated fish passage ladder (ladder on far side of stream). ERR constructed of DOT Heavy {4,500 lb, max weight} stone, all stones set in compression.

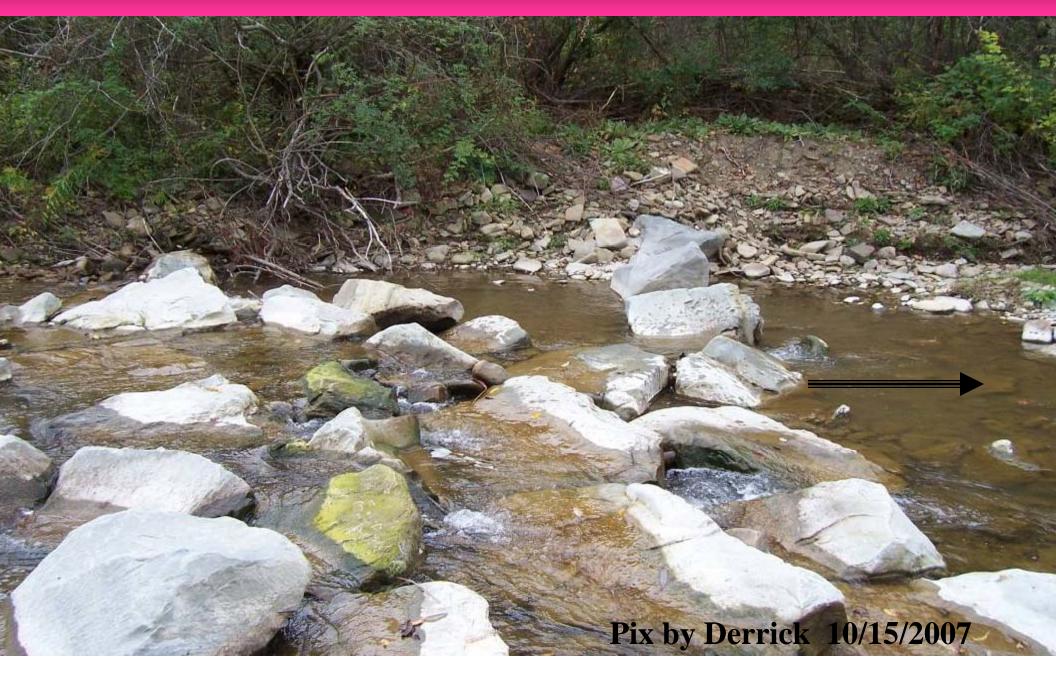
13 Months LATER-low flow. Looking across @ fish ladder.
