#### Maumee AOC Summit Fall/Winter 2012

Thursday, December 6, 2012 9:00am to 12:30pm Toledo Botanical Garden Conference Center 5403 Elmer Dr, Toledo, Ohio 43615

# Ohio EPA Report on Activities in the Maumee AOC

#### Restoration Project of the Ottawa River at the University of Toledo UPDATE

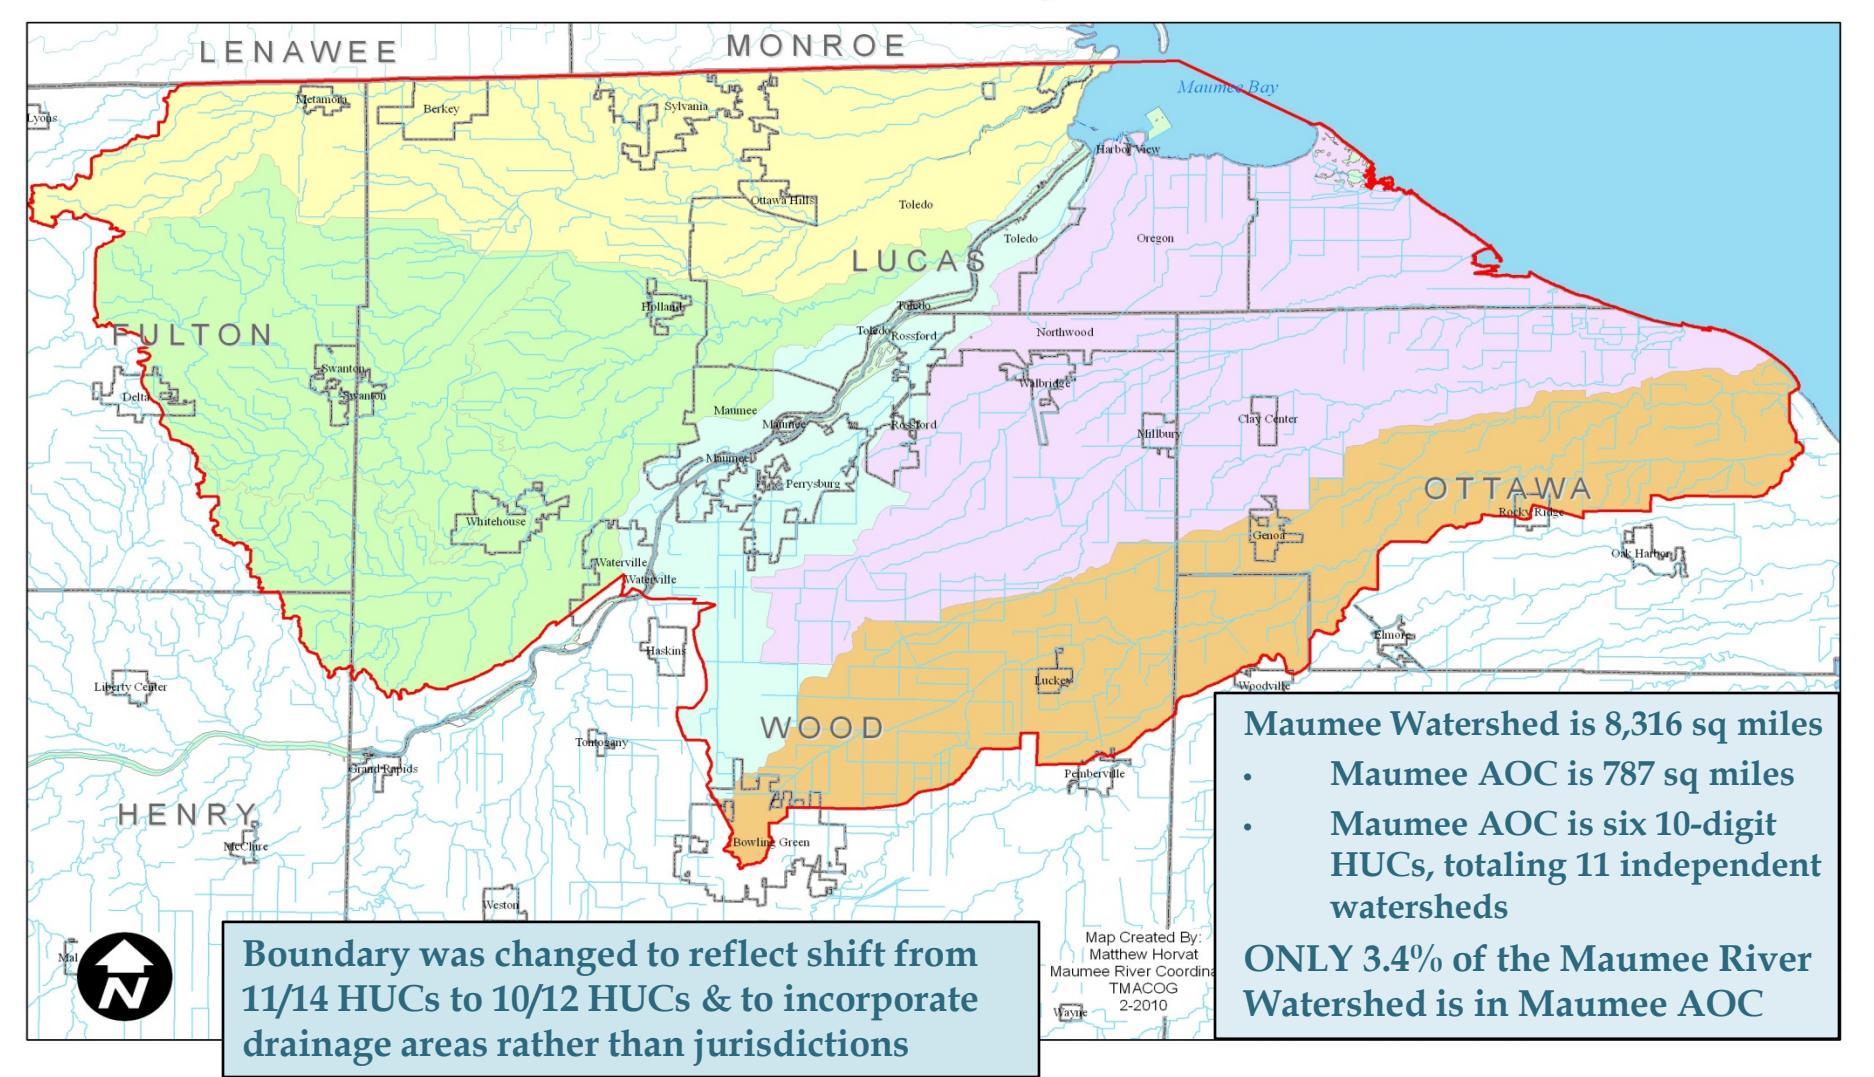
Maumee AOC Boundary

#### Maumee AOC vs. Maumee River

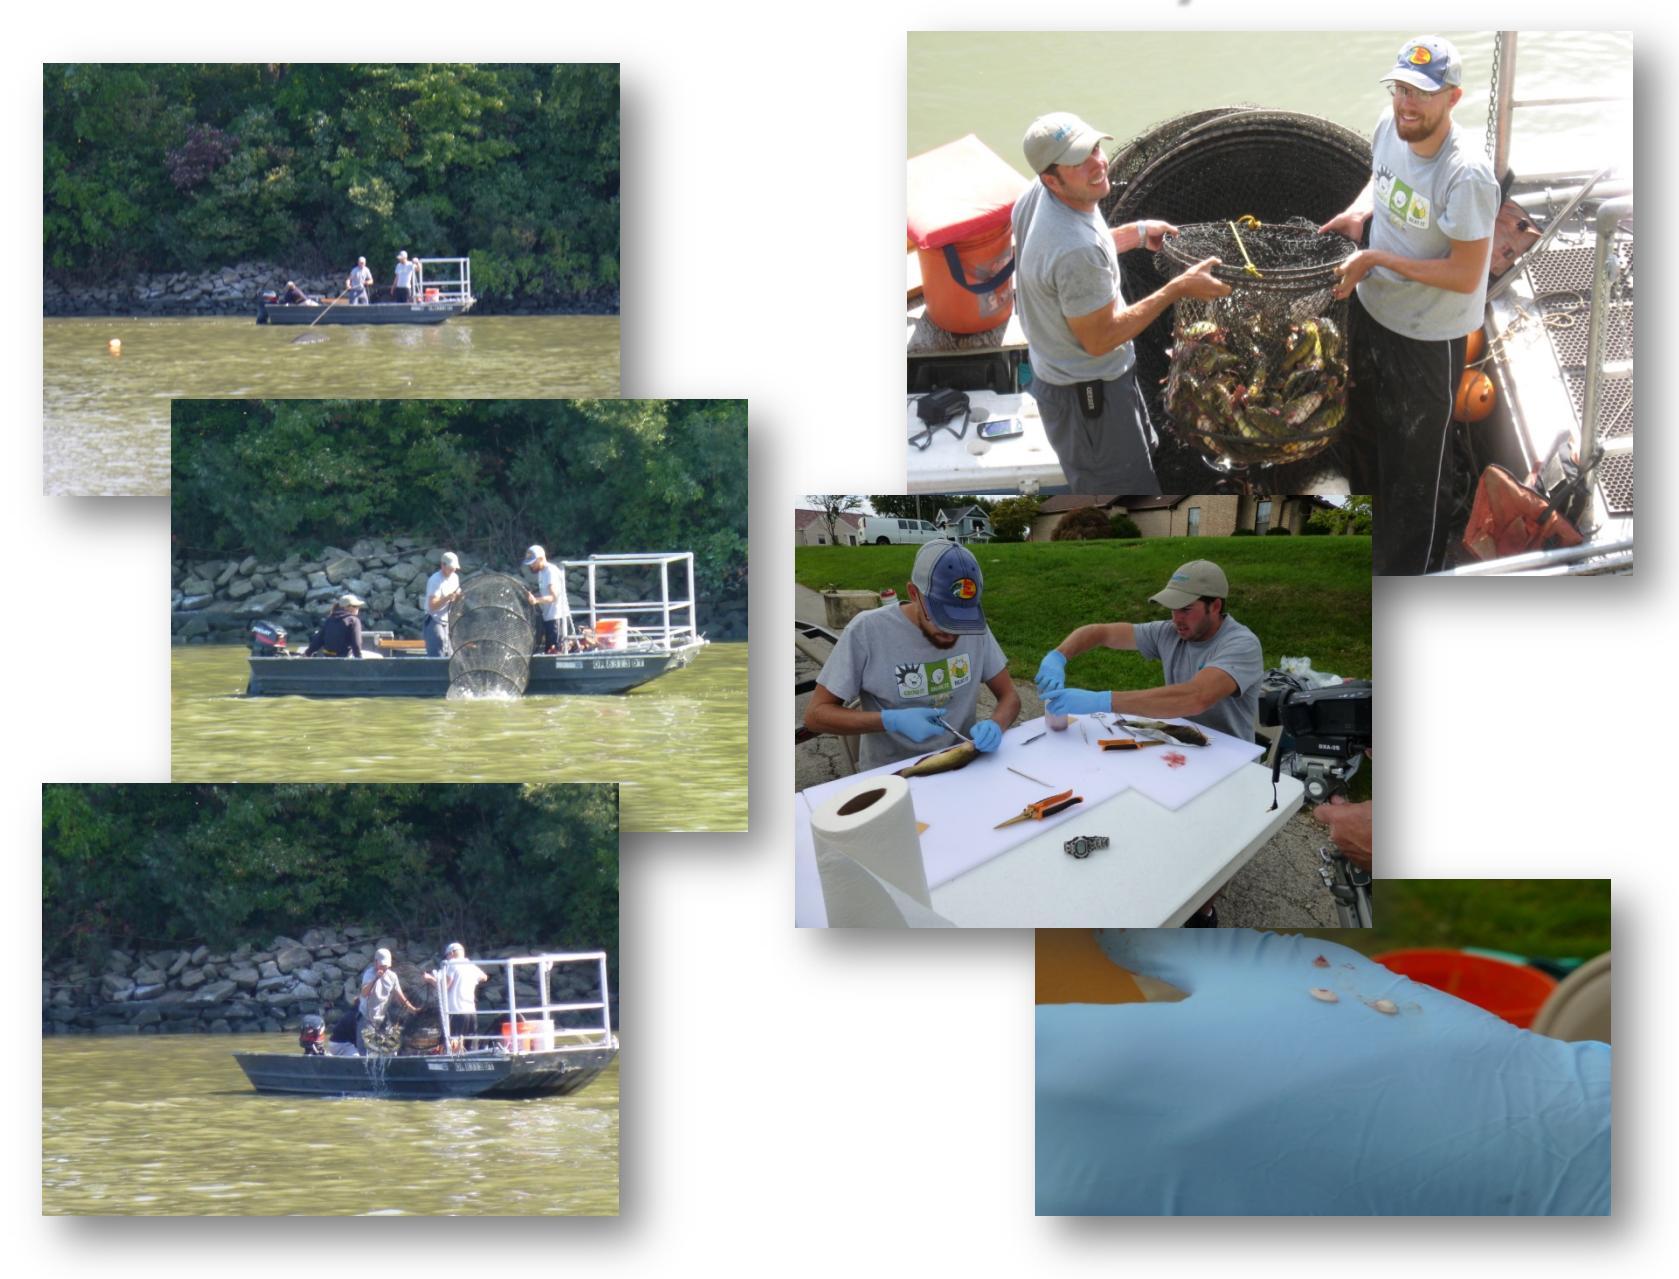
### **BUI 4 Determination Study-Bullhead**

Location	# Bullheads Collected	# of DELT Sites	Notes
Ottawa River	40	5	
Maumee River & Swan Creek	40	16	
Duck Creek & Otter Creek	0	2 of 3	Attempted to access Duck Creek for the second time but low lake levels prevent passage by boat. Sampled 2 DELT sites on Otter Creek.
Wolf Creek	15	2	
Cedar Creek	0	2	
Crane Creek	0	0	Worked with USGS to gain access through Ottawa National Wildlife Refuge, with no access points discovered. Tried accessing from boat launch at Cooley Creek Marina via Lake Erie but low lake levels made passage through the mouth impassable by boat.
Turtle Creek	40	2	
Toussaint River & Packer Creek	40	2 of 3	Could not get access to Packer Creek via Toussaint due to extremely low water levels, attempted to contact private land owner about potential access with no correspondence

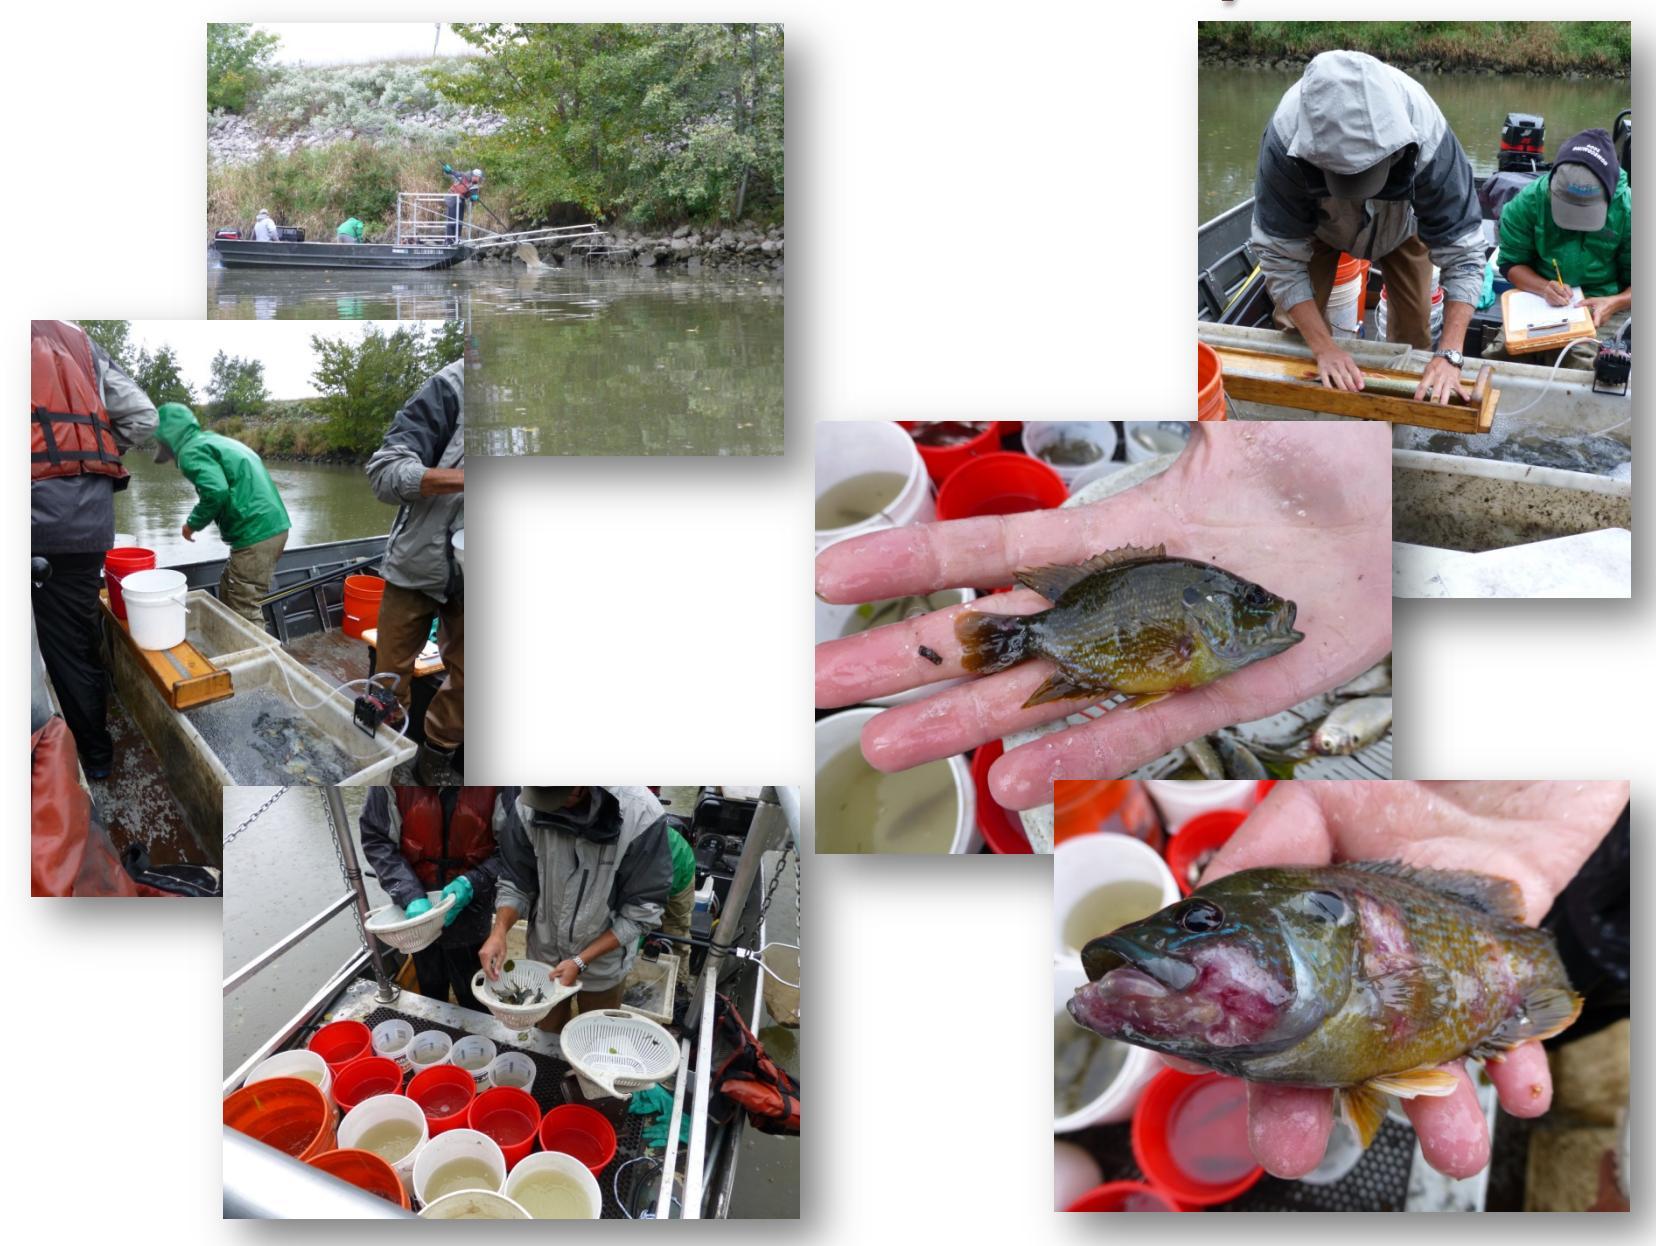
### **BUI 4 Determination Study-DELTs**

- Ohio EPA project funded by GLRI (FFY 2011)
- To determine if BUI 4 is impaired in Ohio AOCs
- Contracted MBI & West Virginia Histology lab
- Sampling conducted Fall 2012
- Attempted to collect brown bullheads for liver tumors and external DELTs near the mouth of each AOC stream
- Also did electrofishing for DELTs near the mouth of each AOC stream

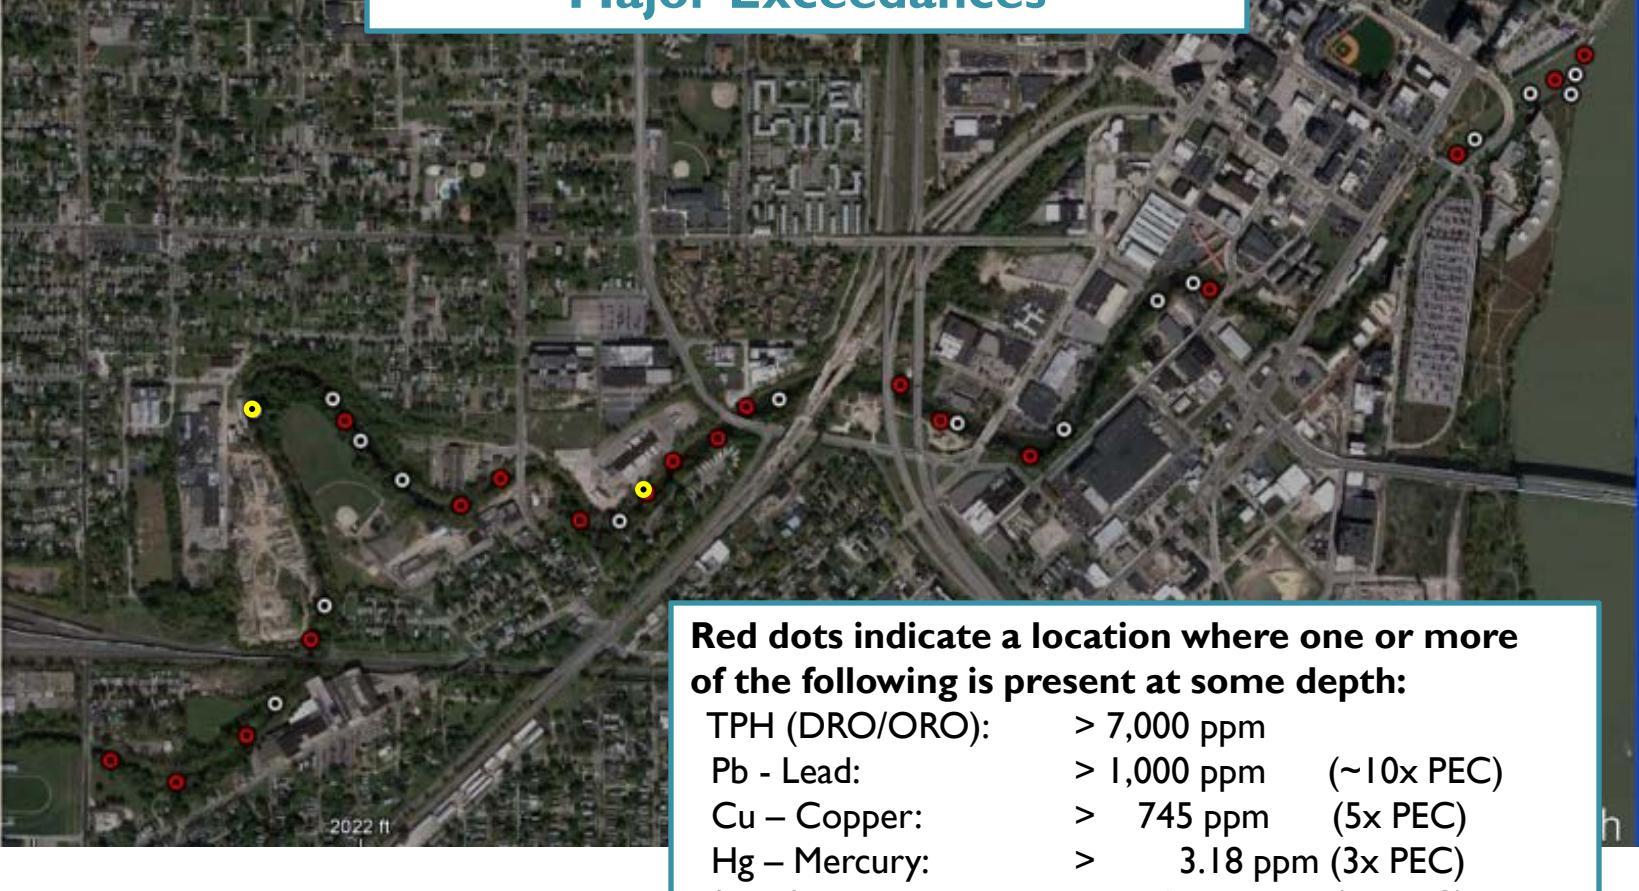
- 100 sediment samples from 35 locations using vibracore and push-probing
- Intervals were 0-6", 6-24", 24-48", 48-72"
- QHEI assessed at 6 locations every ~2,000 ft
- Issues Encountered:
  - Poor sediment recovery
  - Difficult station access/navigation

As – Arsenic:

TPAH:

PCB:

> 165 ppm (5x PEC)

- Metals contamination resides in deeper sediments (> 24") especially in the downstream area,
- Total Petroleum Hydrocarbons (oil and diesel) and PAH are found throughout the project area at all depths.
- PCBs were found in the upstream portion of the project area, additional sampling needed.

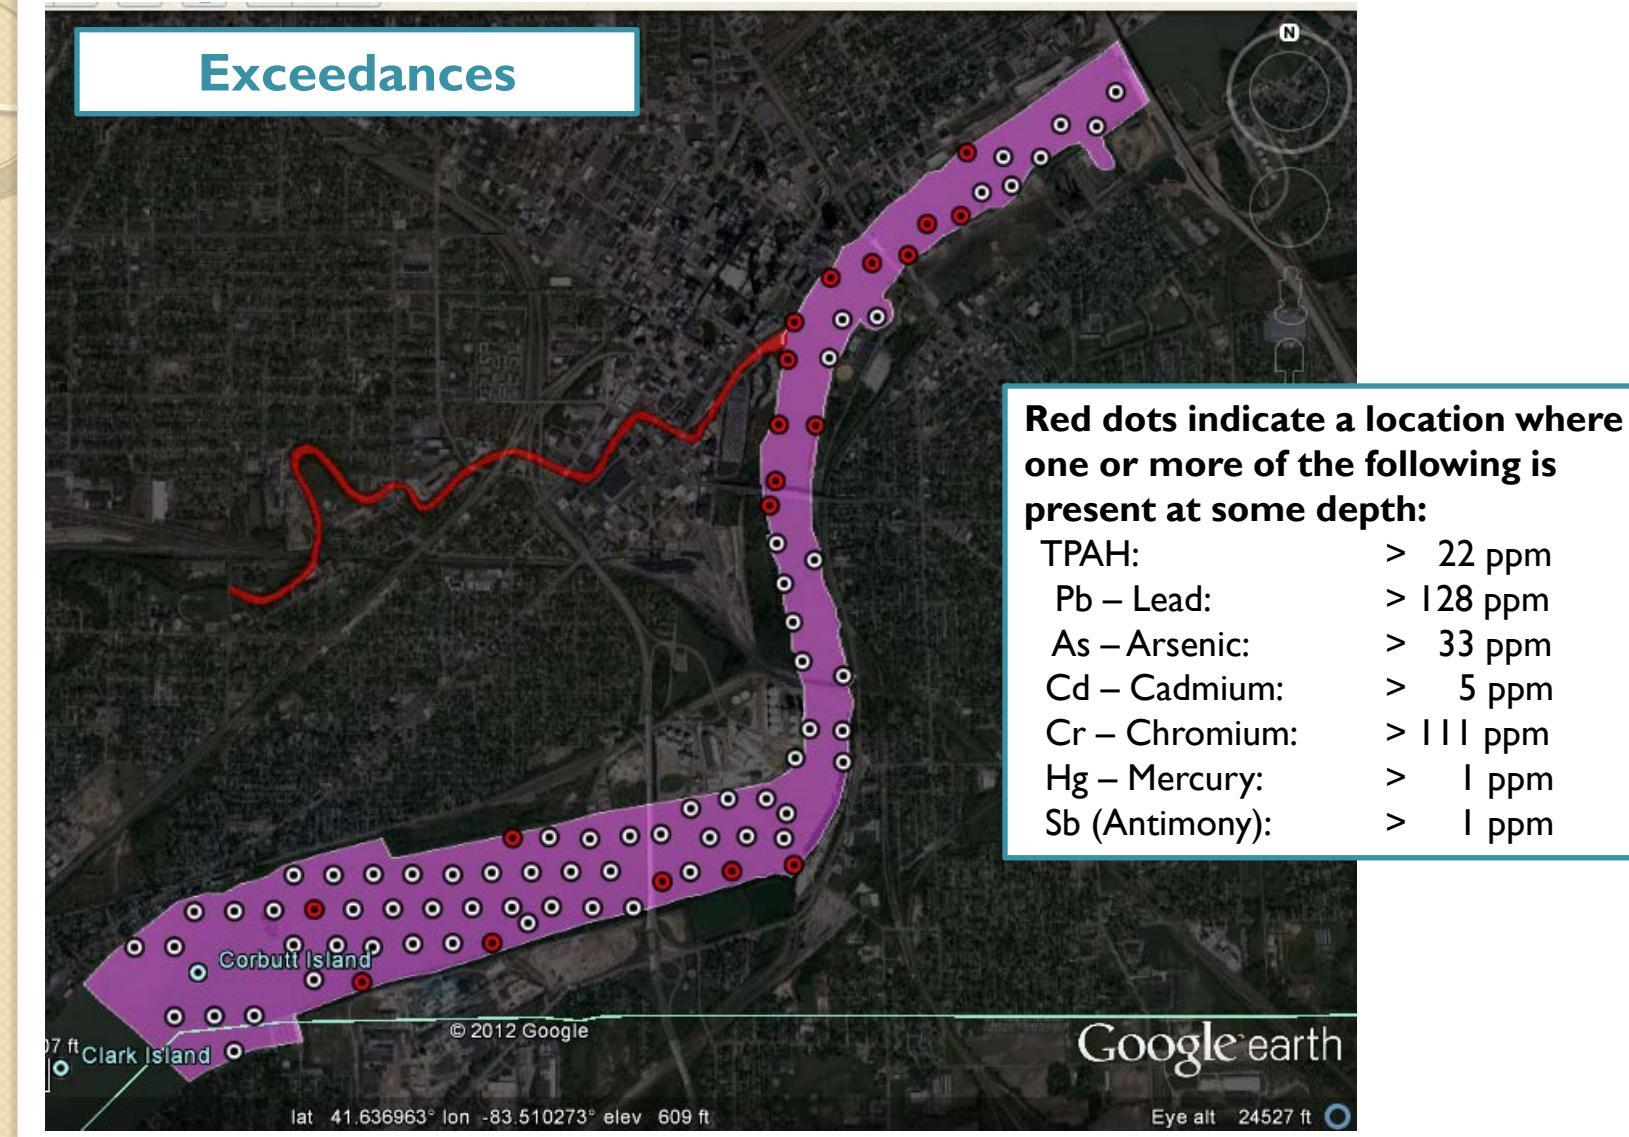
## Site Characterizations – Maumee R. (Phase I)

- Conclusions
  - Very few spatial trends or correlations, exceedances span wide range of depths
  - Arsenic (As) trend is along south bank upstream of I-75
  - Antimony trend is surficial based with linkage to Swan Creek. Lab detection was difficult.
  - TPH, Cd, Mercury associated with Oakdale Ave. CSO, at depth
  - Lead Follows west-bank downstream from High-Level Bridge
  - PAHs downstream from Swan Creek at over 200+ ppm
  - Barium east bank, possible shoreline source?
  - Cadmium/Chromium and Lead may note other hotspots
- Next Steps
  - At this time, no additional sampling is being planned for this Project Area

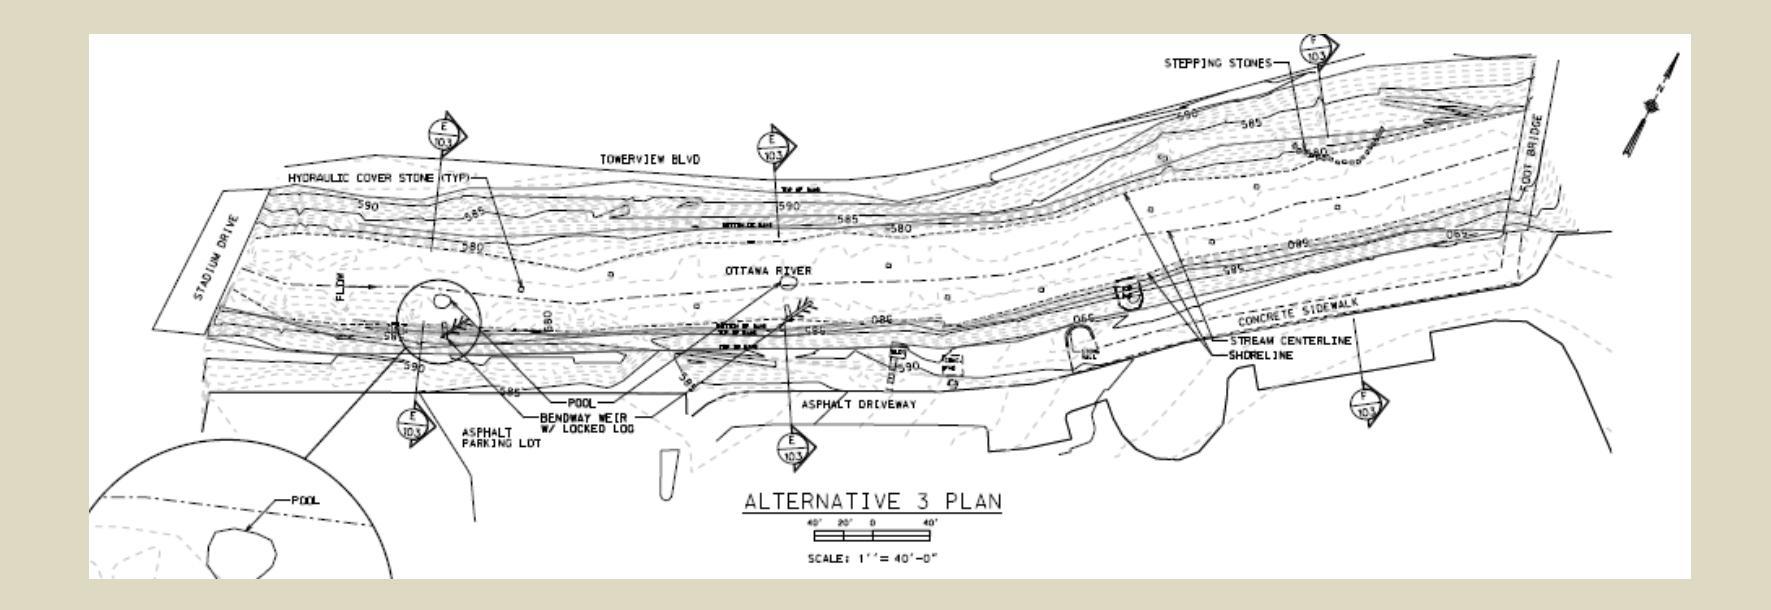
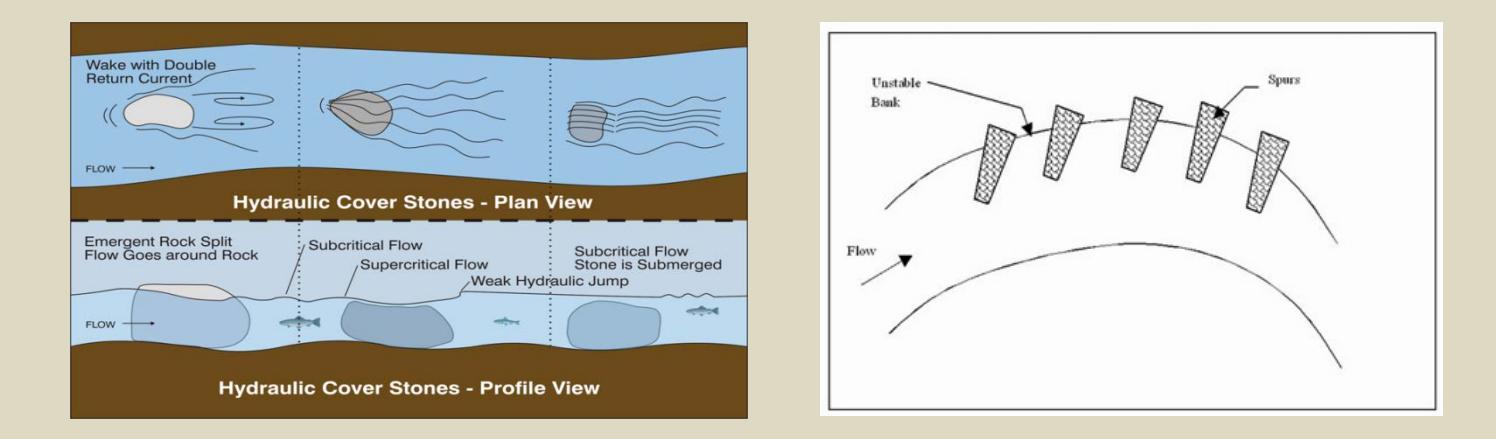
With funding secured from Stranahan Foundation in 2009 planning started on proposed in-stream and bank restoration for selected reach on UT campus, 900 feet adjacent to Savage Area, UT entered into agreement with ACOE Buffalo in FY11 to complete necessary survey, hydrological modeling and draft concept plans

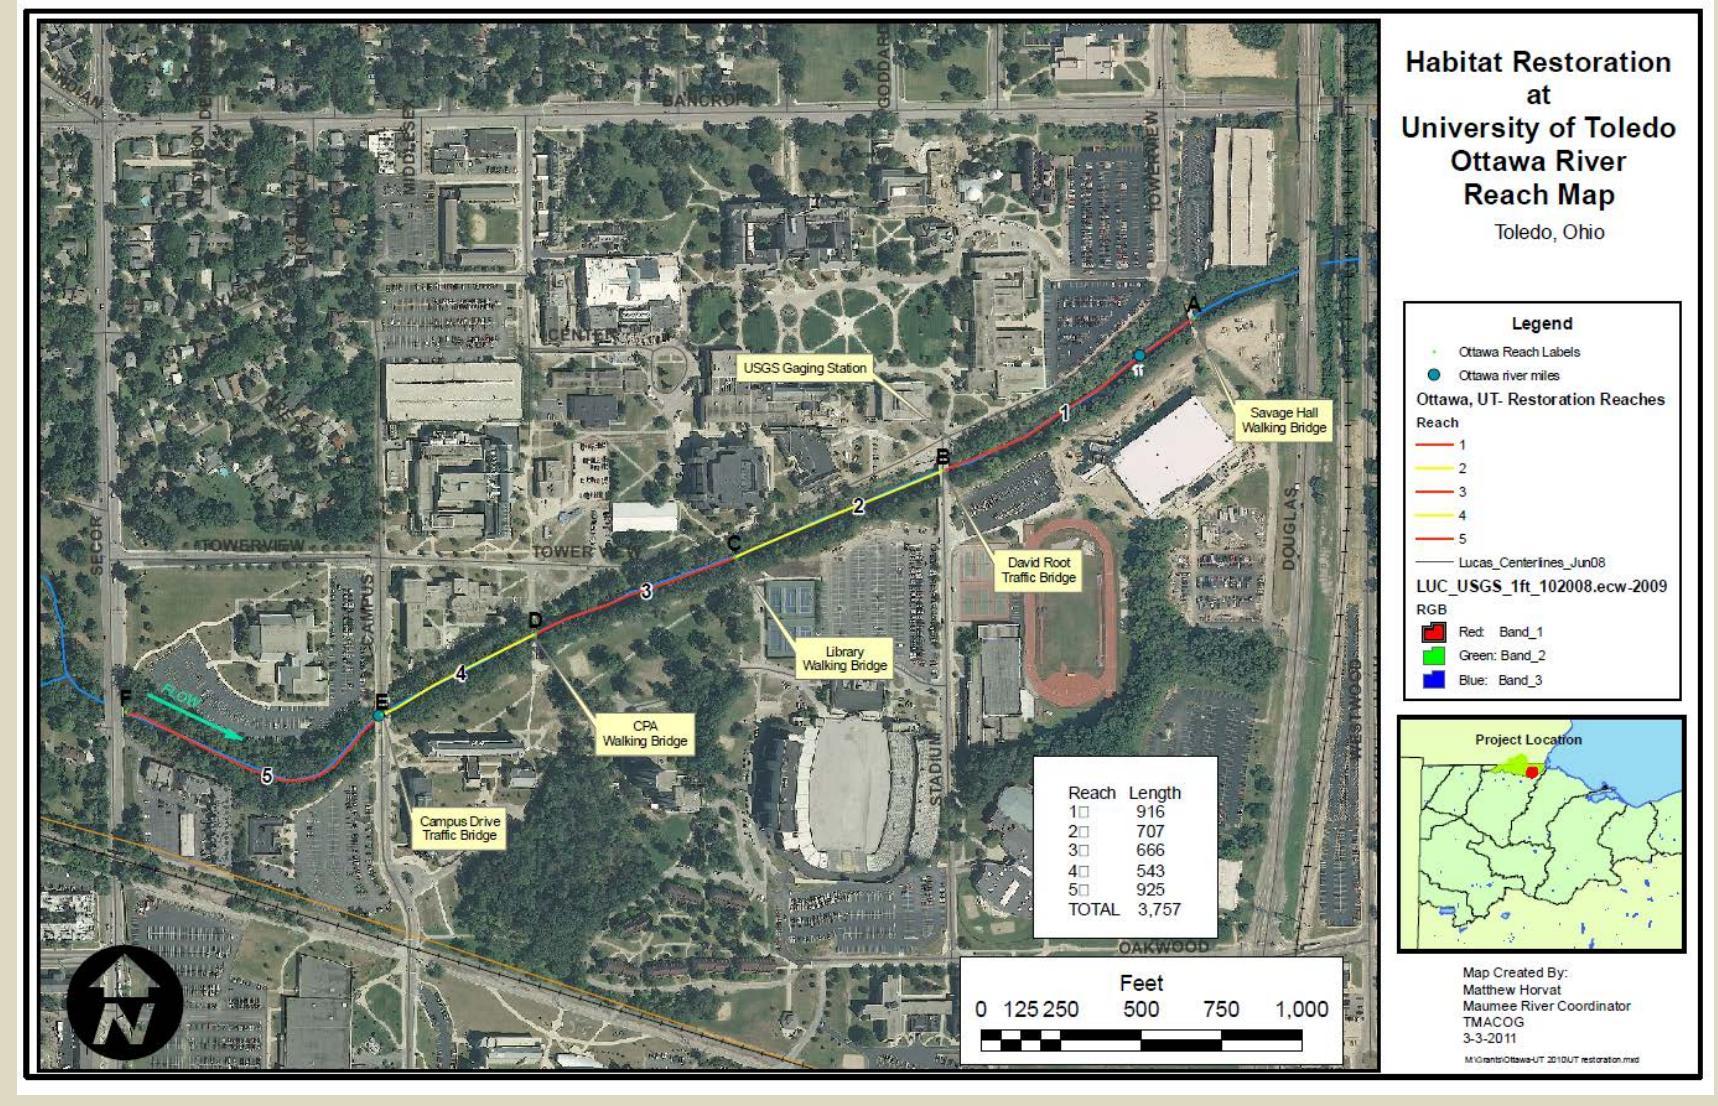
Initial concept plans for river restoration of river reach 5 (900 feet adjacent to Savage Arena) as presented by ACOE Buffalo at March 2011 workshop

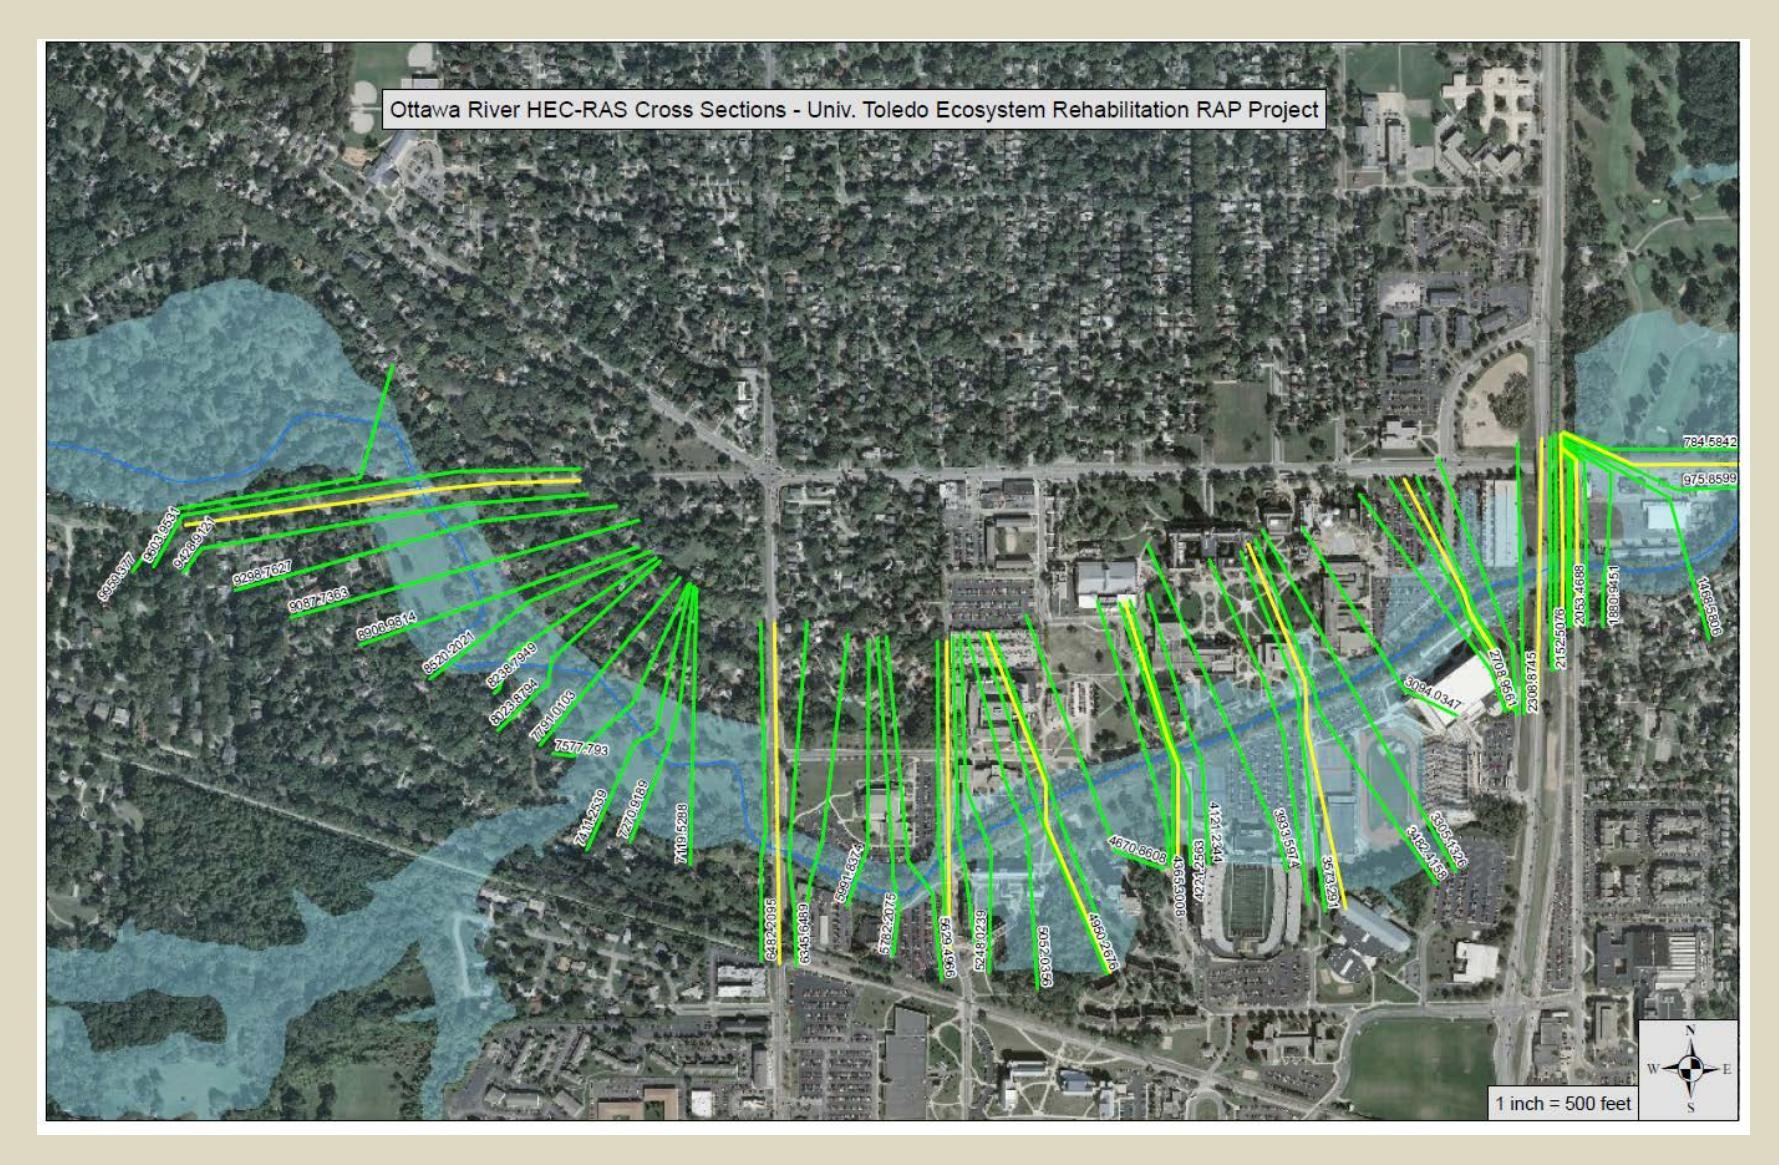
In February 2012 ACOE Buffalo conducts hydrological modeling of stream flow conditions with proposed in-stream restoration features in place following Reach 1-5 concept plans

Peach	Evicting	Original Concent	WSE riso
Neach			(f+)
	(IL NAVDOO)	(11 NAVD88)	(11)
1	594.88	595.12	0.24
	594.48	594.71	0.23
2	594.18	594.31	0.13
	594.11	594.24	0.13
3	593.76	593.87	0.11
	593.46	593.55	0.09
4	593.21	593.28	0.07
	593.16	593.22	0.06
5	593.08	593.14	0.06
	592.69	592.68	-0.01

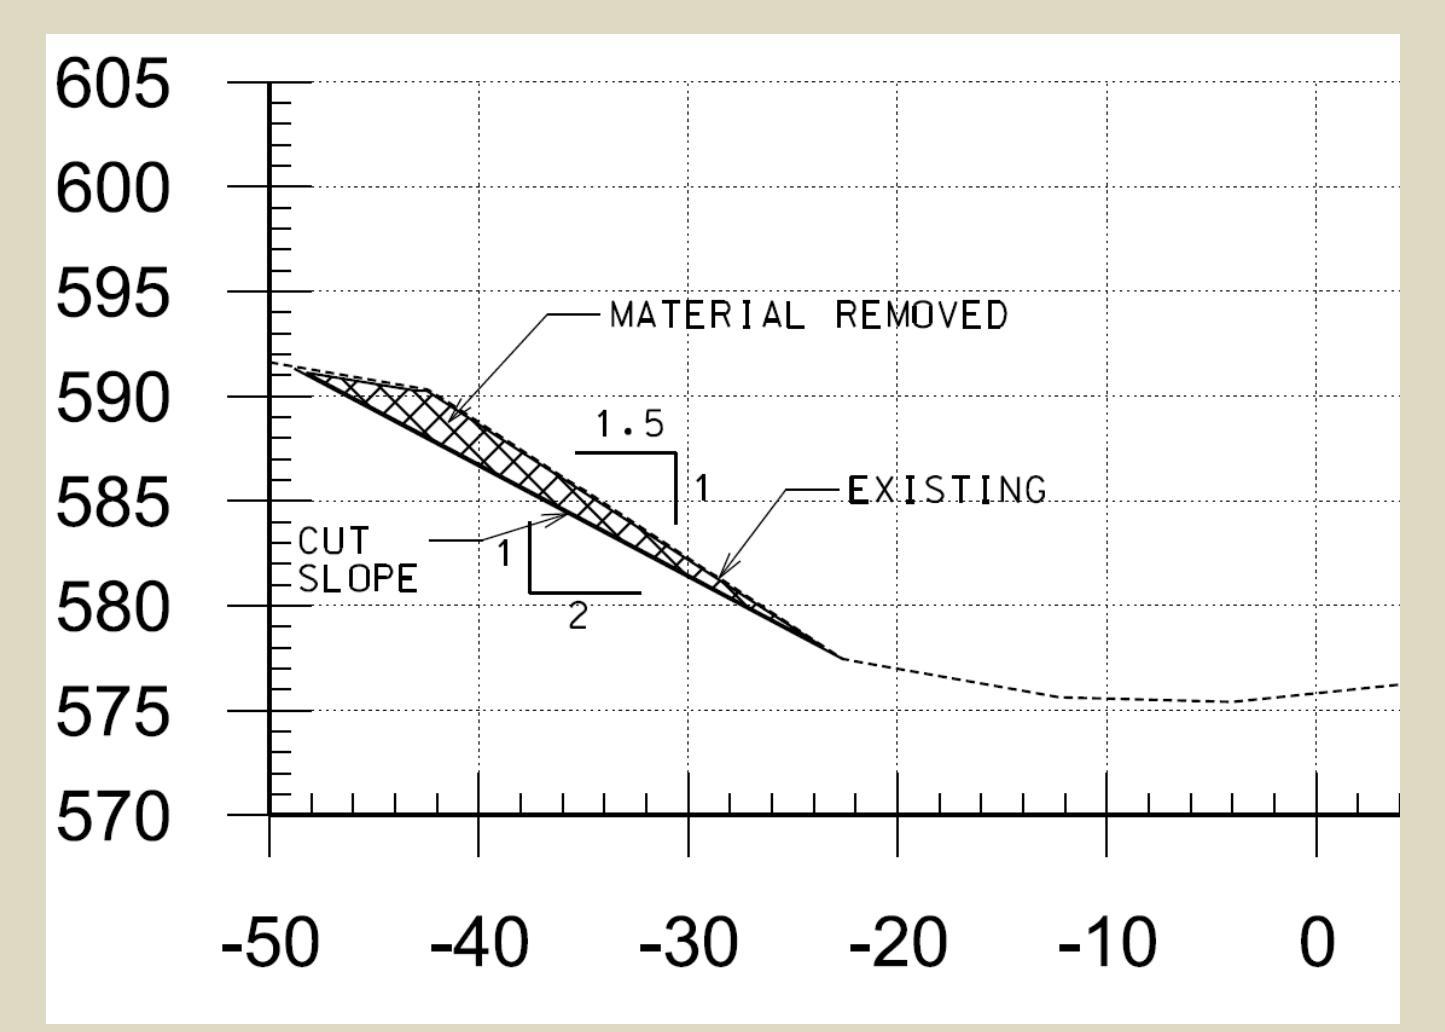
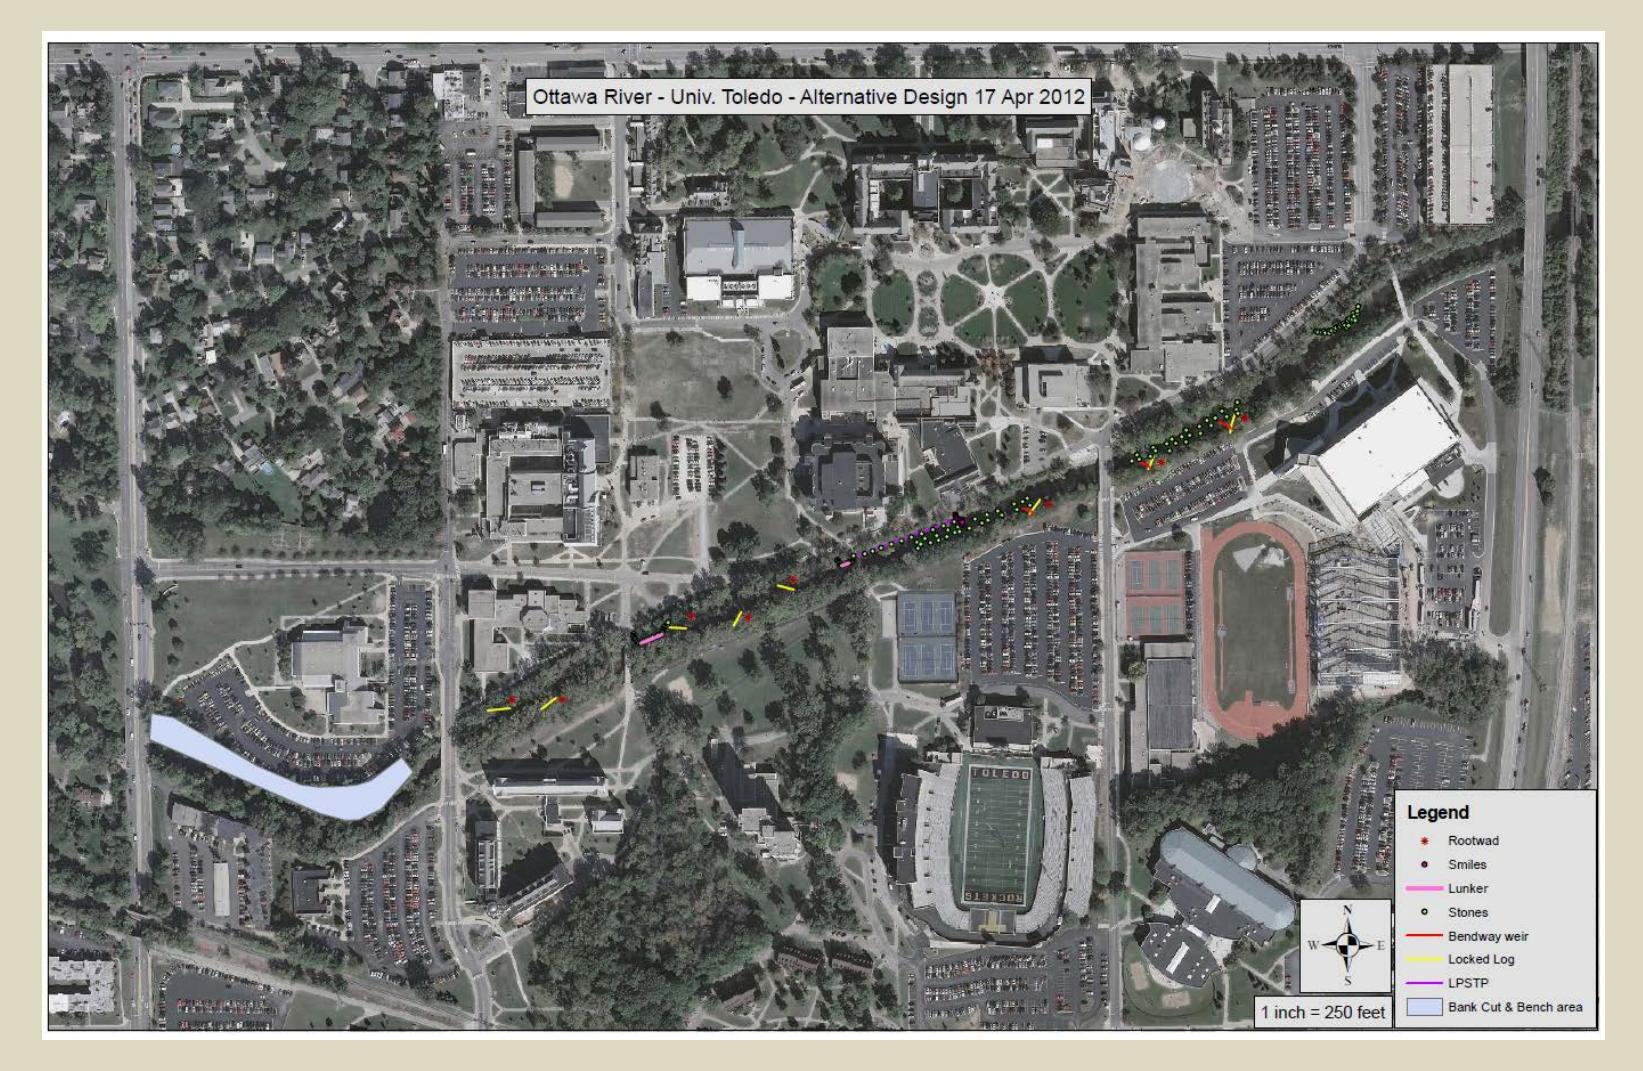
Another approach is proposed by ACOE Buffalo to create a series of cut bank features (see concept below) in reaches s 1-3 to provide for additional excess flood capacity storage in additional to continued reduction in the number, type and size of in-stream structures especially in reaches 1-3.

In April 2012 ACOE Buffalo completes final analysis and proposes a 900 foot cut bank in reach one along with alternative plan for in-stream restoration structures in reaches 2-5.

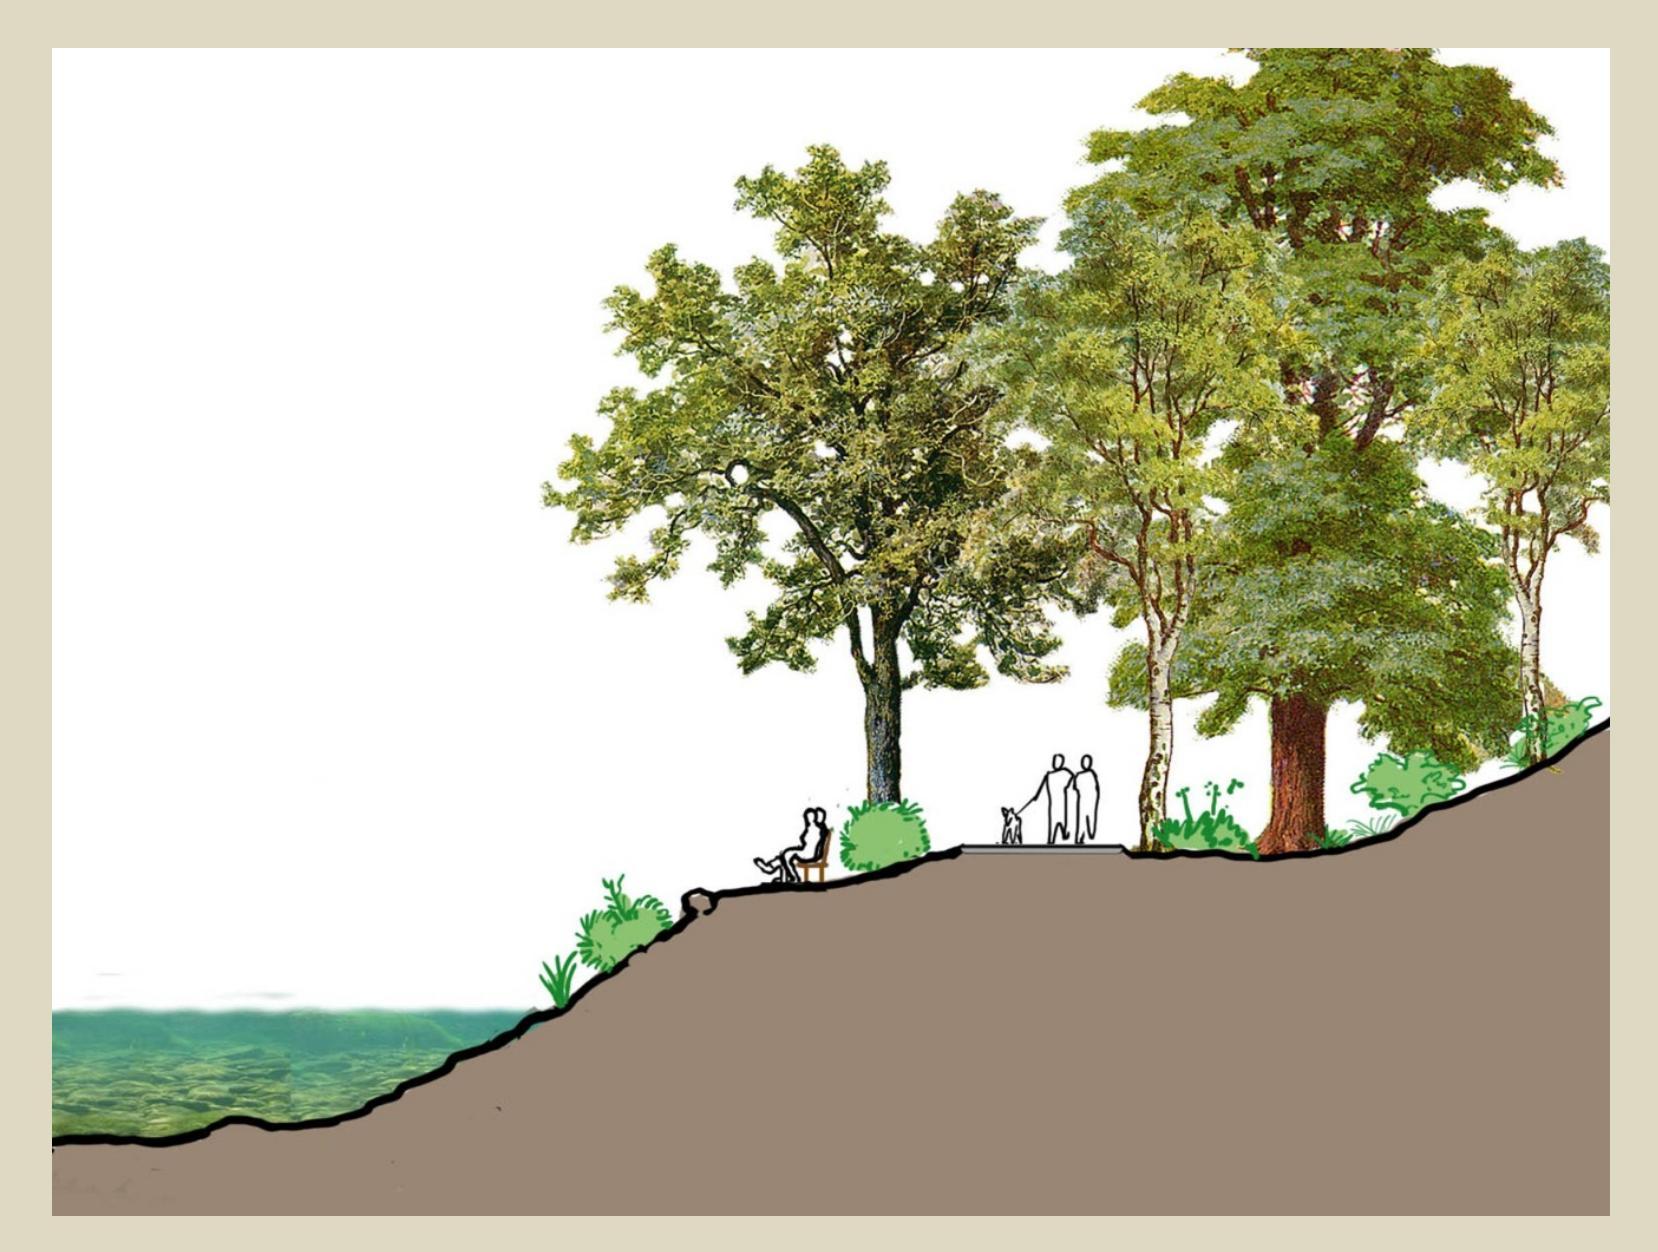
Final design for Phase I of the UT Ottawa River Restoration Project: construction of a cut bank in reach 1, north bank adjacent to the UT Law School (June 2012)

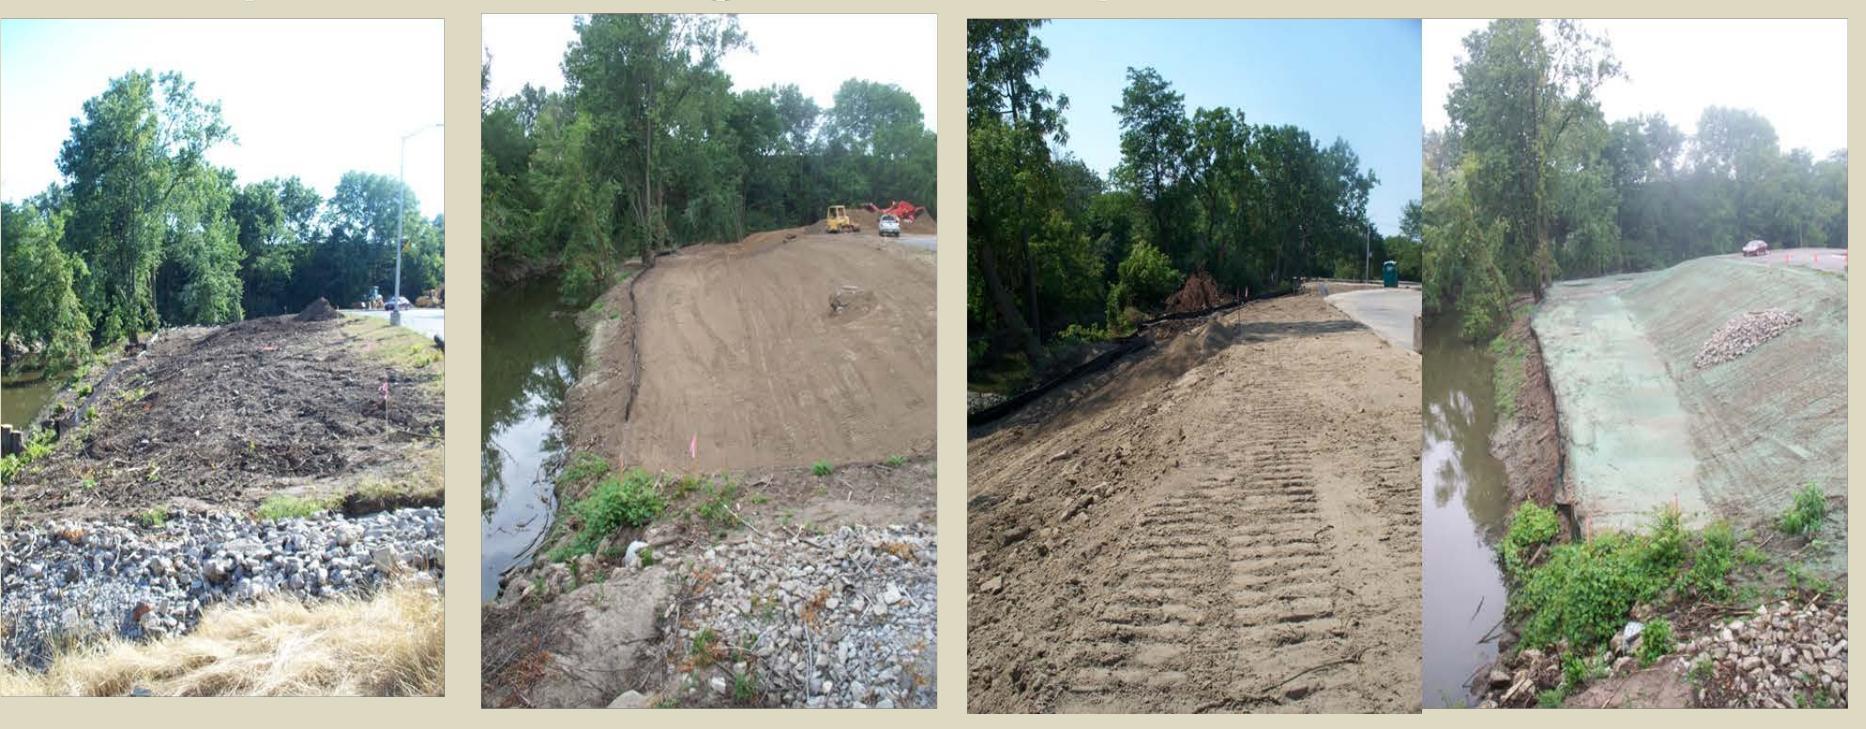
# Stages of the Construction of the Cutbank (June to August 2012) photos below

Approximately 4,700 cubic yards of concrete fill (placed in late 1950s) was removed, screened on site with all concrete, woody debris recycled; clean sediment reused on site as topsoil
