#### Maumee AOC Summit Fall/Winter 2012

Thursday, December 6, 2012 9:00am to 12:30pm Toledo Botanical Garden Conference Center 5403 Elmer Dr, Toledo, Ohio 43615

# Ohio EPA Report on Activities in the Maumee AOC

#### Restoration Project of the Ottawa River at the University of Toledo UPDATE

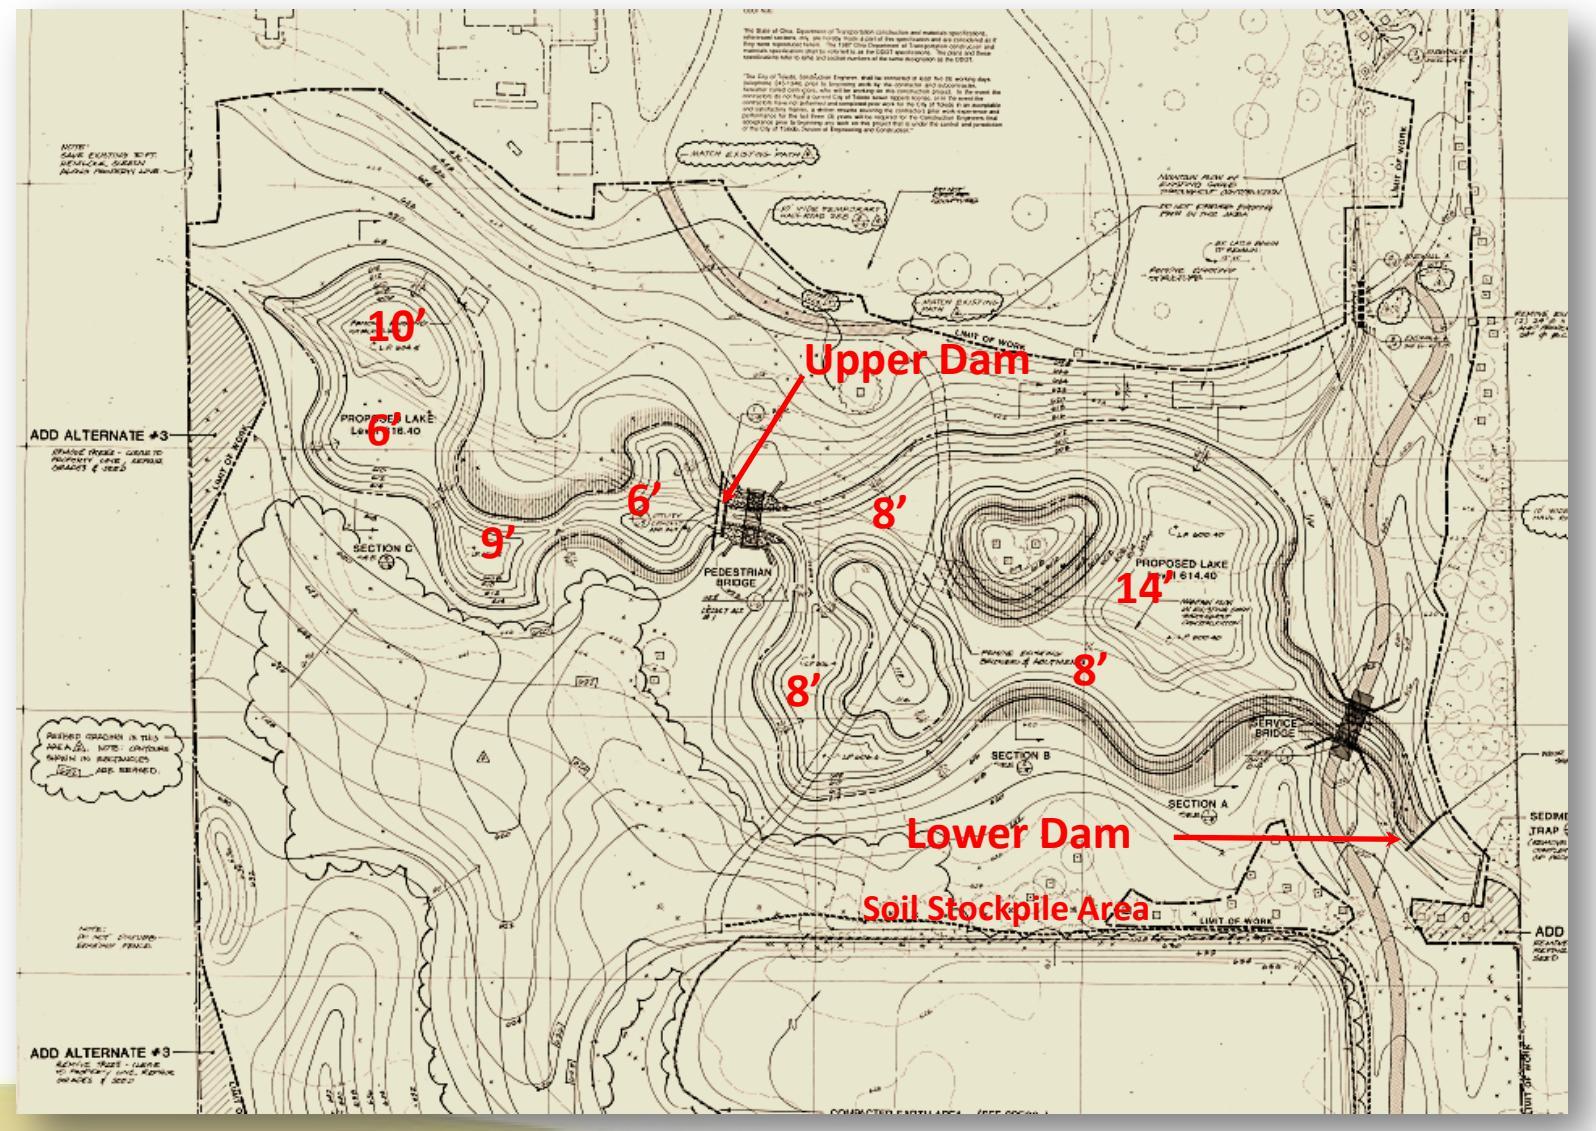
#### **1988 Design of Crosby Lakes**

Numbers represent pond design depths

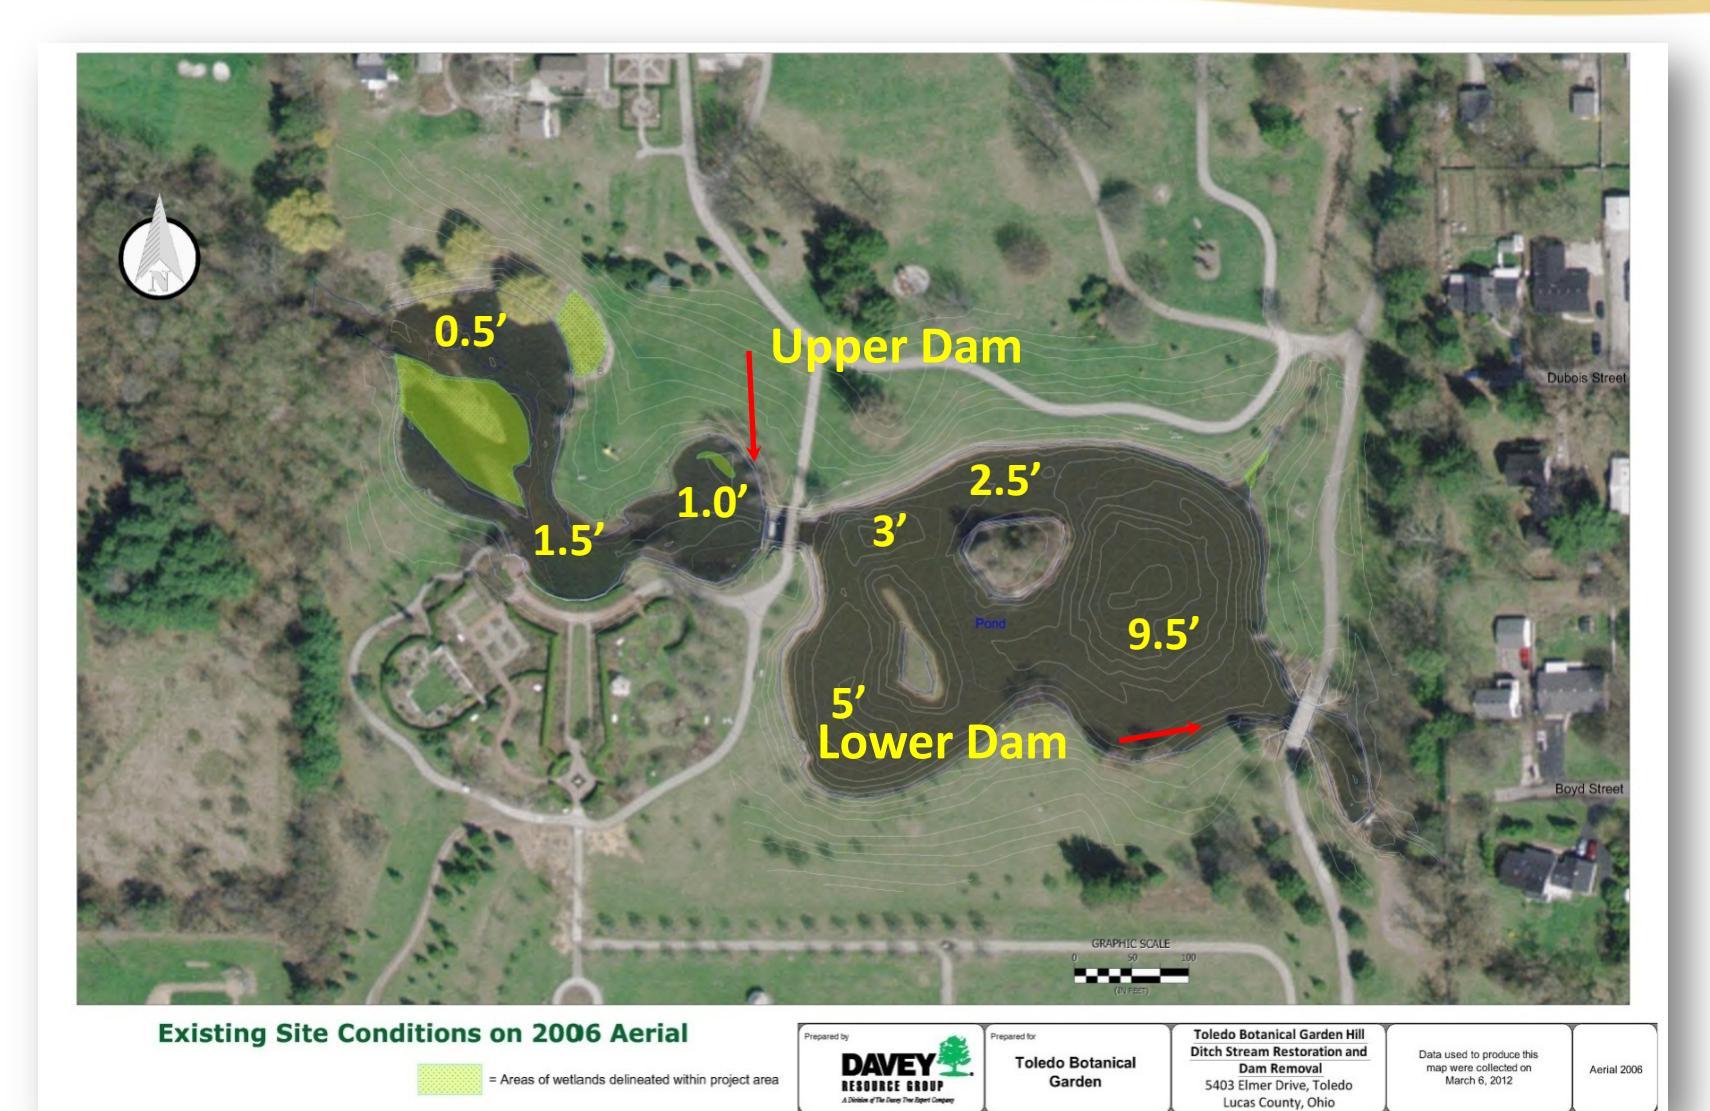
#### **Current Conditions**

Numbers in yellow represent approximate depths today

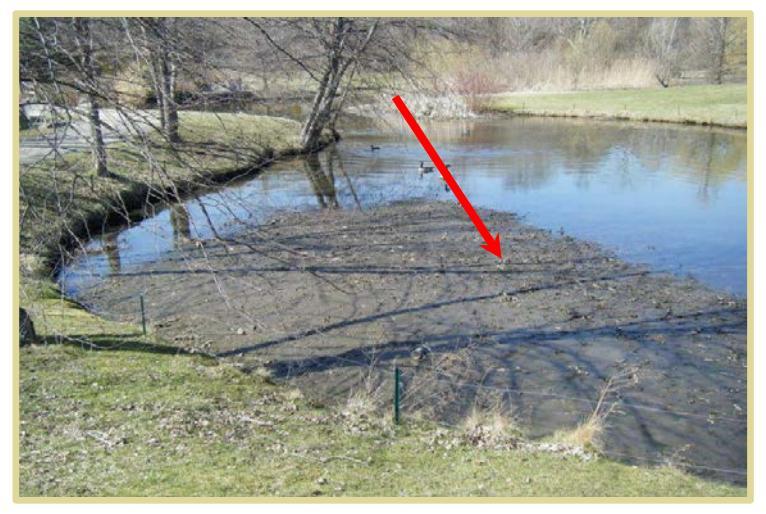
**Accumulated sediments**

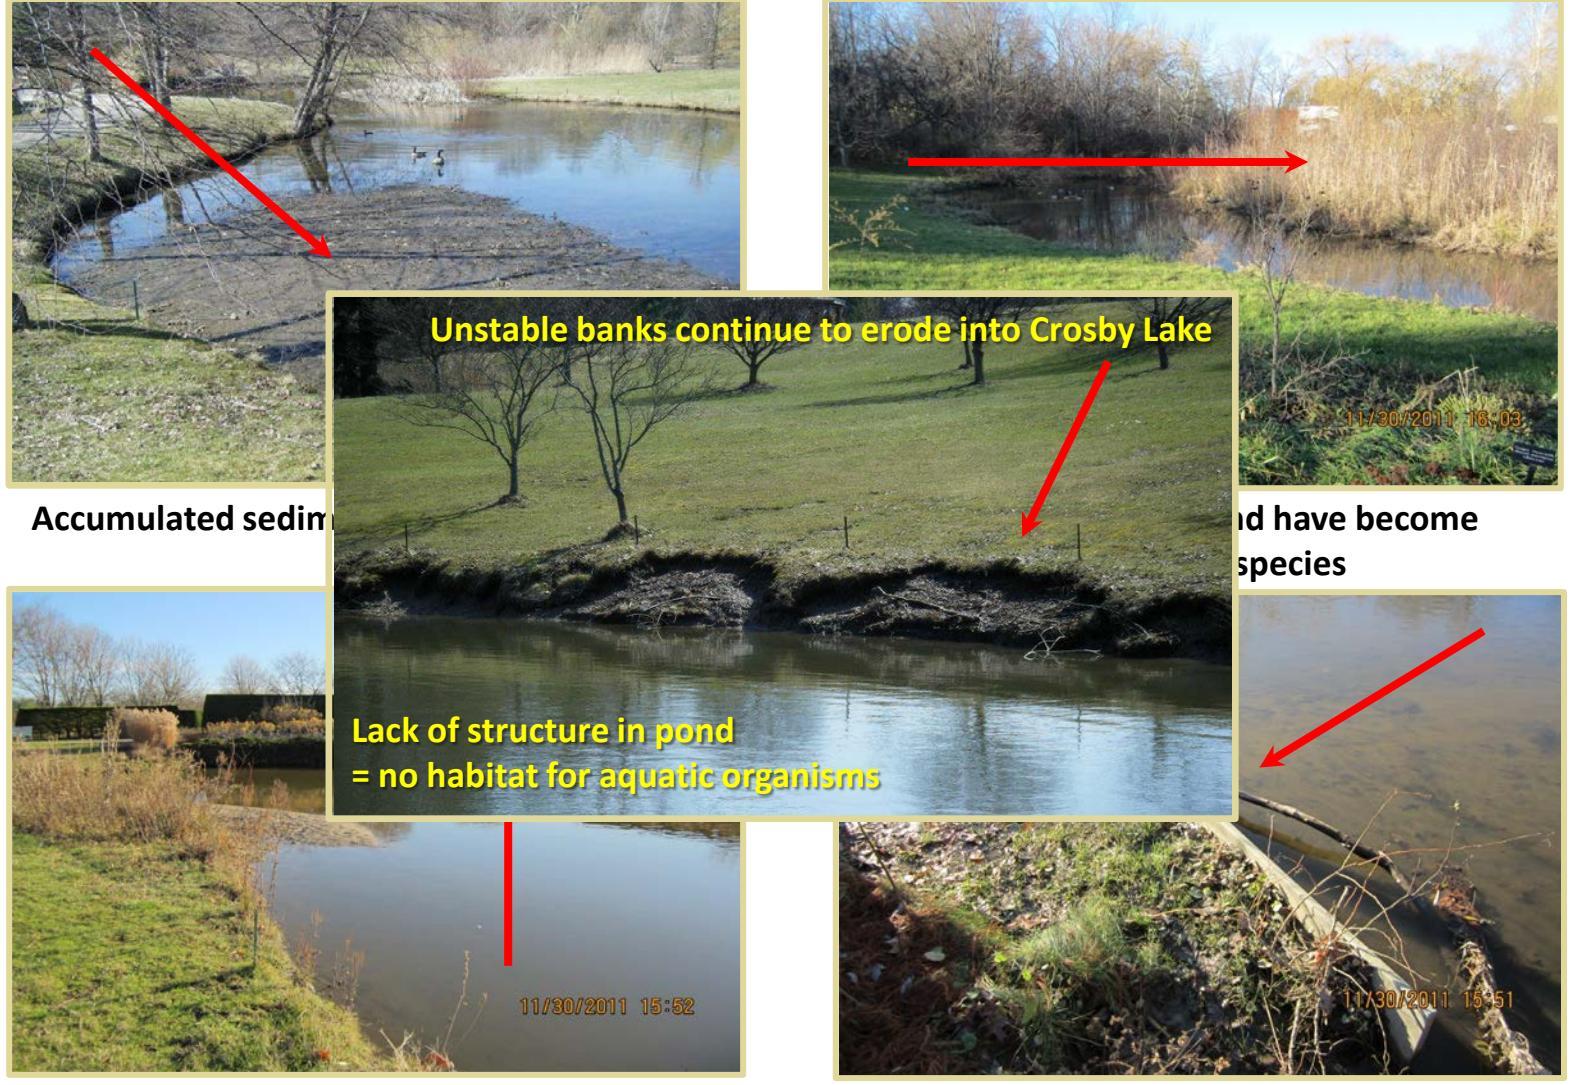
An unstable shoreline discourages visitors from getting close to the pond

Hard edges provide no cover for aquatic animals

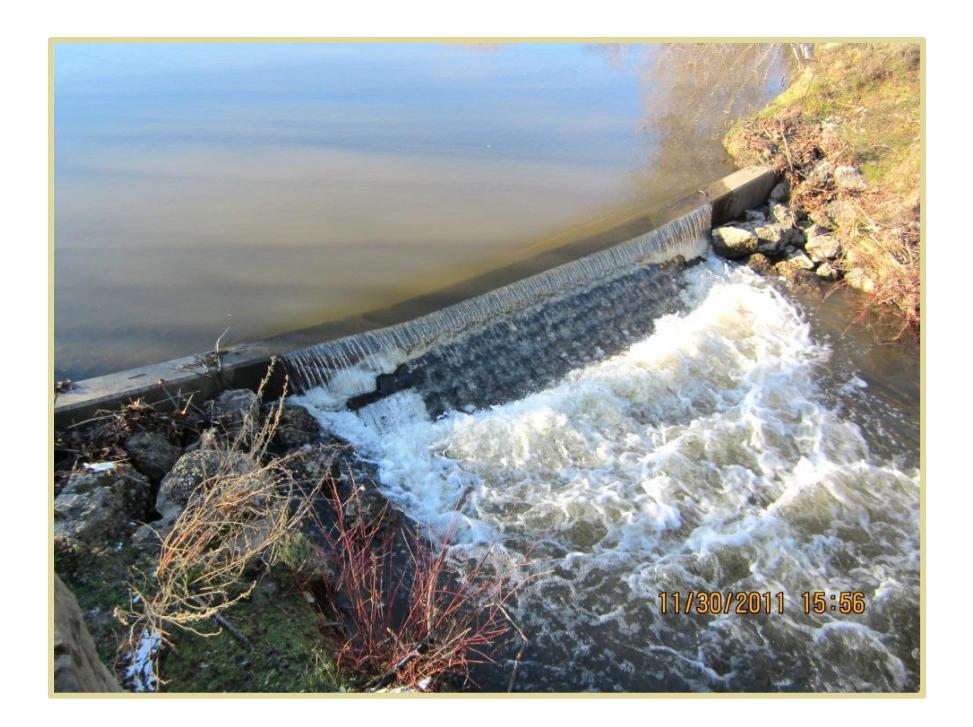
#### **Upper Dam**

- Promote sediment buildup
- Prevent the movement of aquatic life

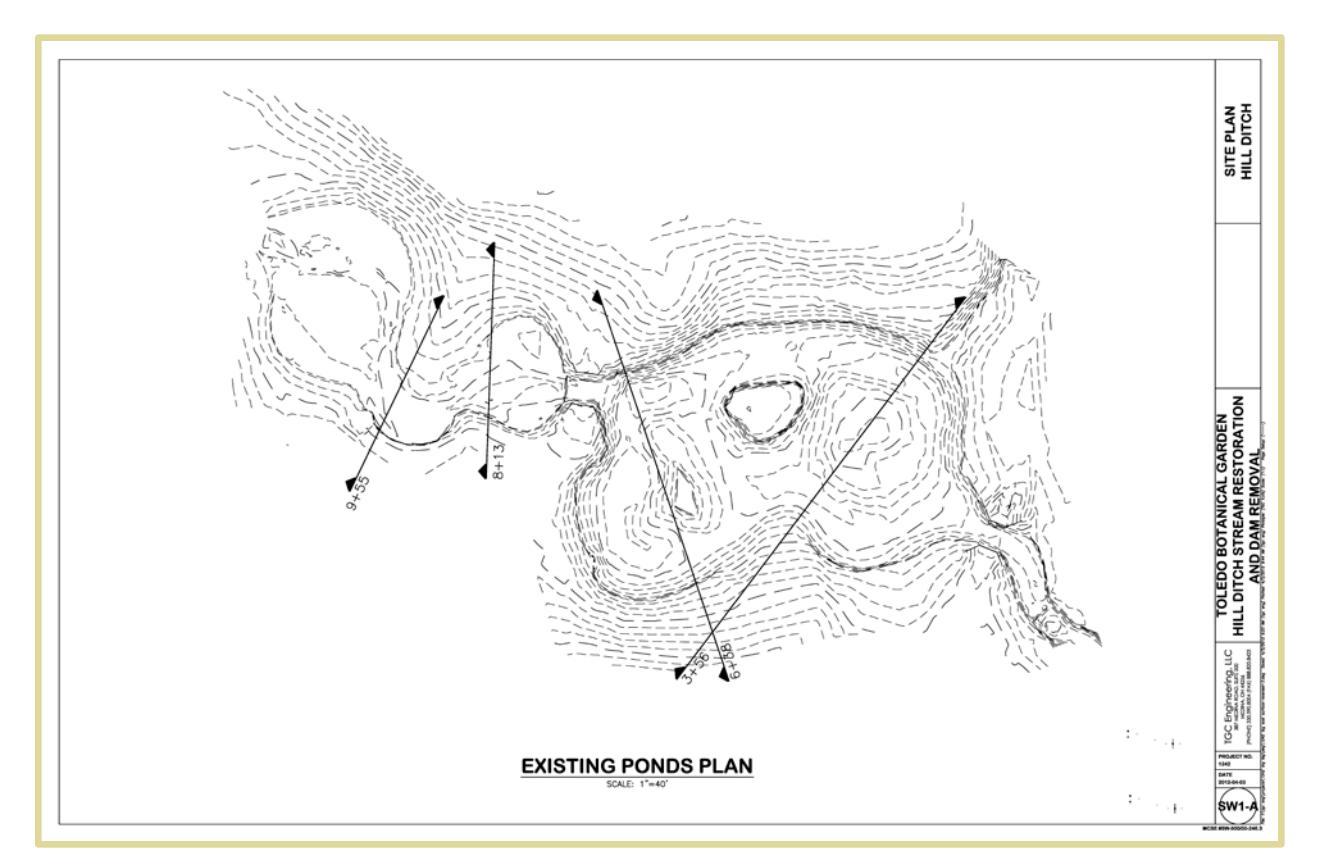
This data was run through a model based on current conditions and on possible modified conditions

**GOAL:** To determine if proposed changes would effect water levels or water speed/volume up or downstream of TBG.

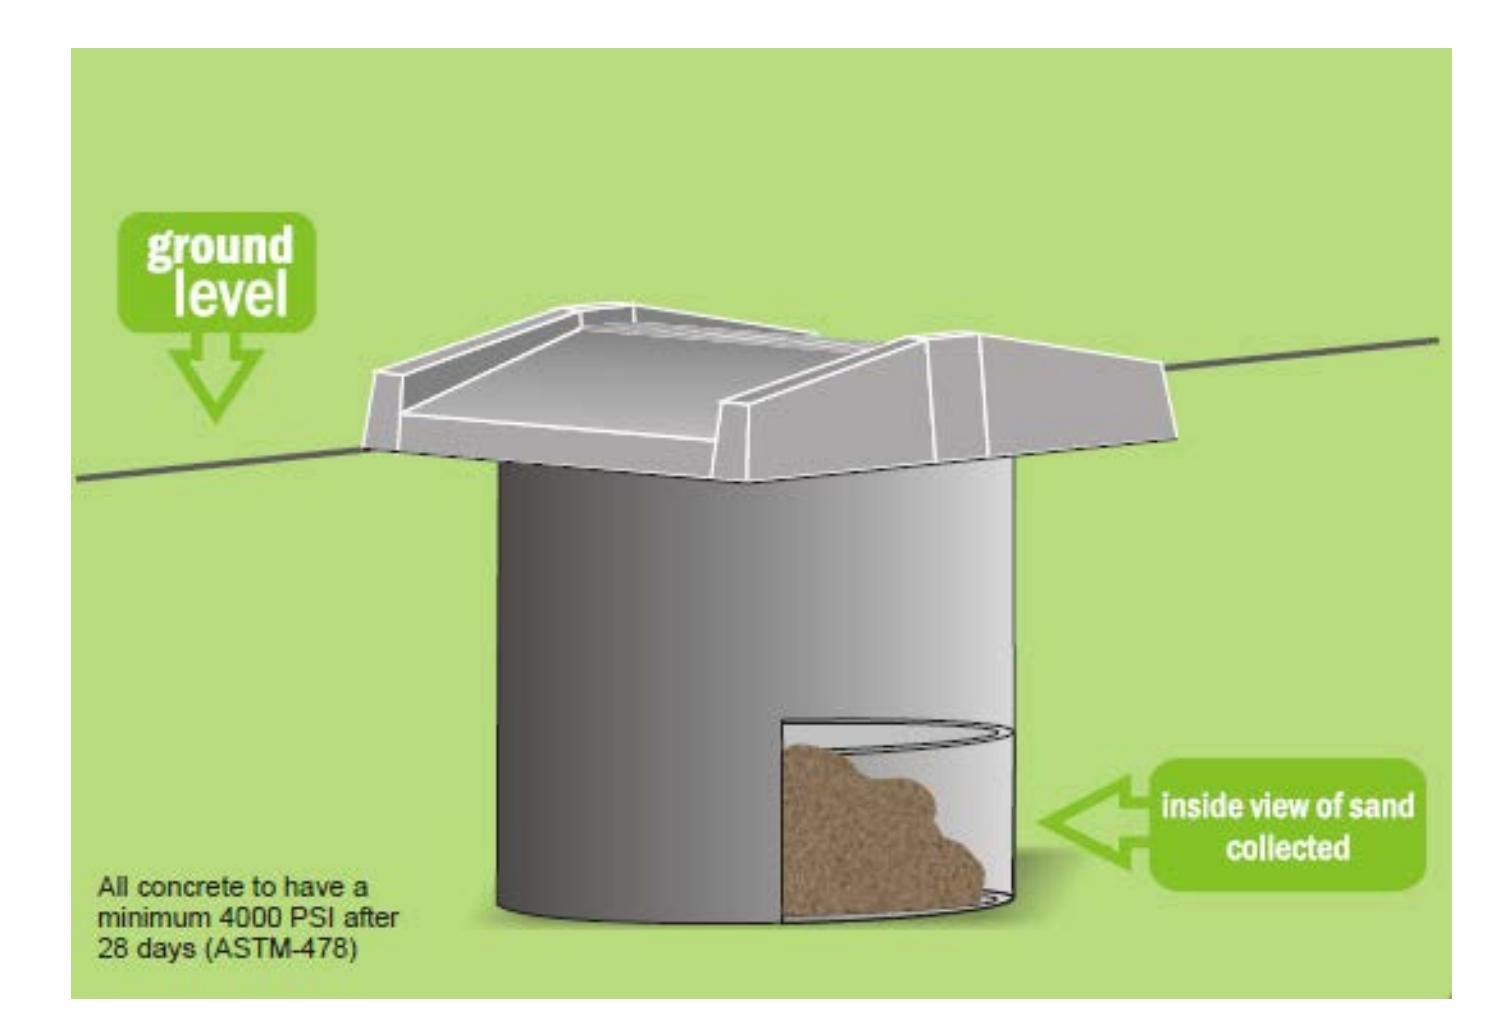
#### Streamside Systems ®

Sediment Removal without Dredging

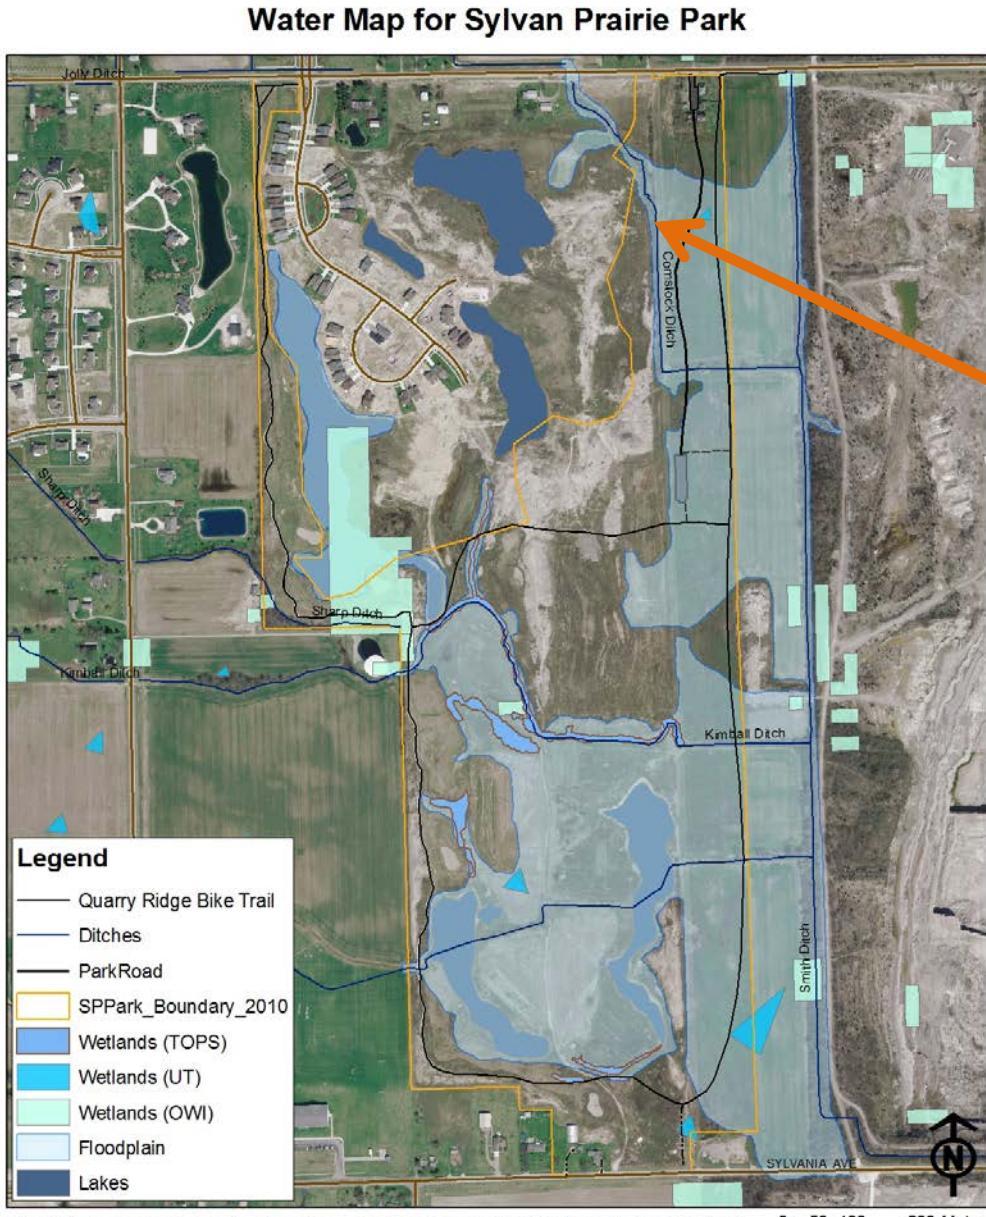
## To Fix this ... Change Ditch System to Low Gradient (energy)

- Lower velocity
- More sinuosity
- More floodplain
- Wetland
